## U.S.S. CLAMAGORE (SS-343)

# Hull Survey

Vessel Survey Report No. 2344

Purpose of survey: Structural Survey

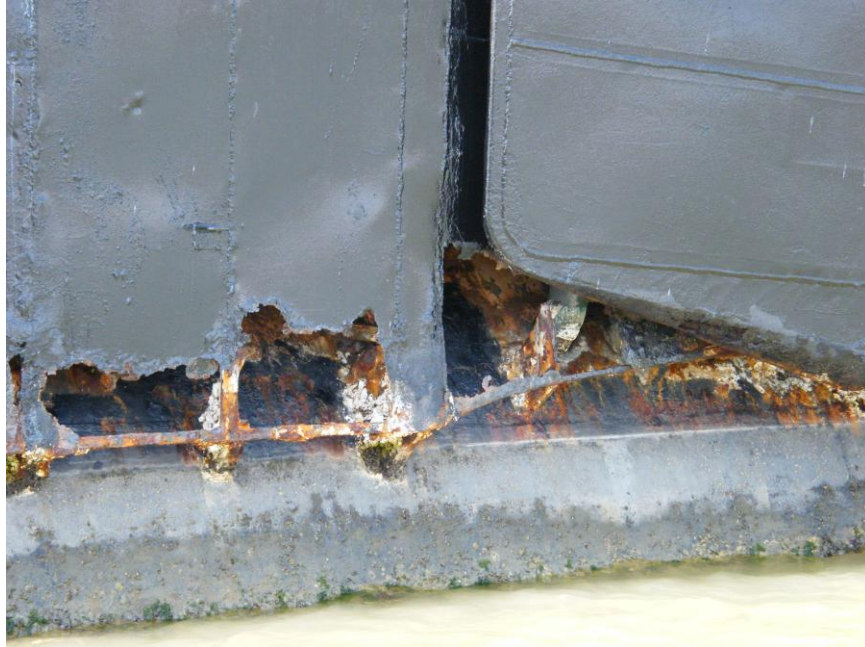
Detail of forward plane to starboard, showing wasted superstructure deck framing and face plating.

*The two bow planes appear to be in fair condition in that the hinges for both planes (what is visible) appear in tough condition. The foundations/bases for these planes are deteriorating badly. Additional reinforcement will be needed. There is interior degradation of the planes with wastage holes at the bottoms of both planes.*

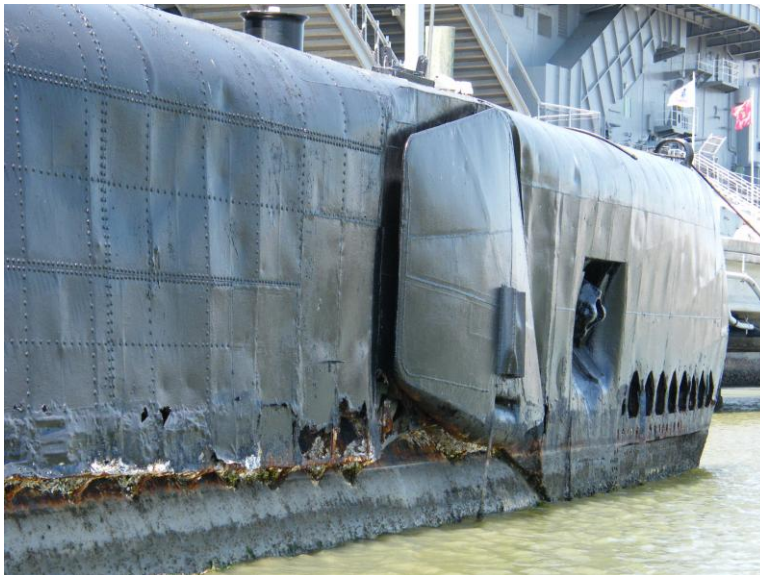
Forward plane to starboard, showing wasted superstructure deck framing and face plating.

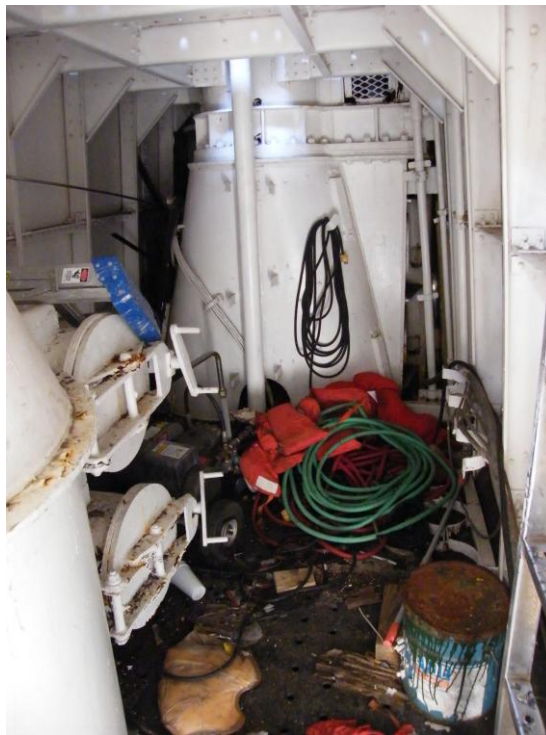
Looking aft in sail just above maindeck. Notice careless storage of gear and paint.

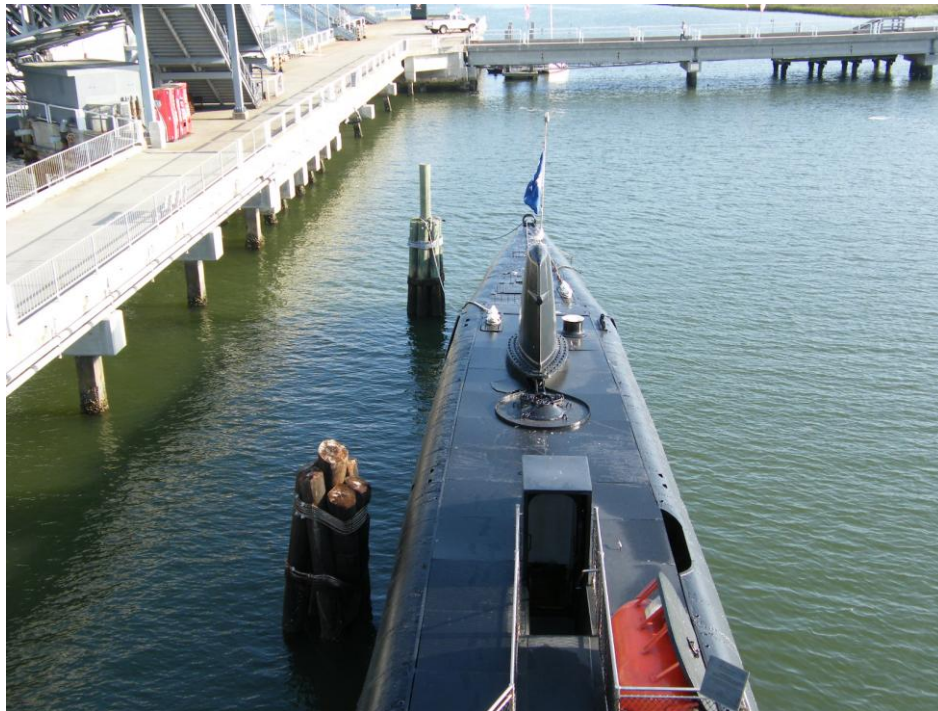
**Foredeck profile, showing area forward of the sail.**

The maindeck also has temporary outboard handrails/railings with lifelines fitted along the length of the deck facilitating passage from the access hatches. A painted semi-non-skid finish has been applied to the steel deck for footing; this is in relatively good condition with rust/scale at the perimeters of hardware and hatches.

**Minor trip/fall hazards abound with the uneven decking throughout the length of the maindeck. Not suitable at this time for public access.**

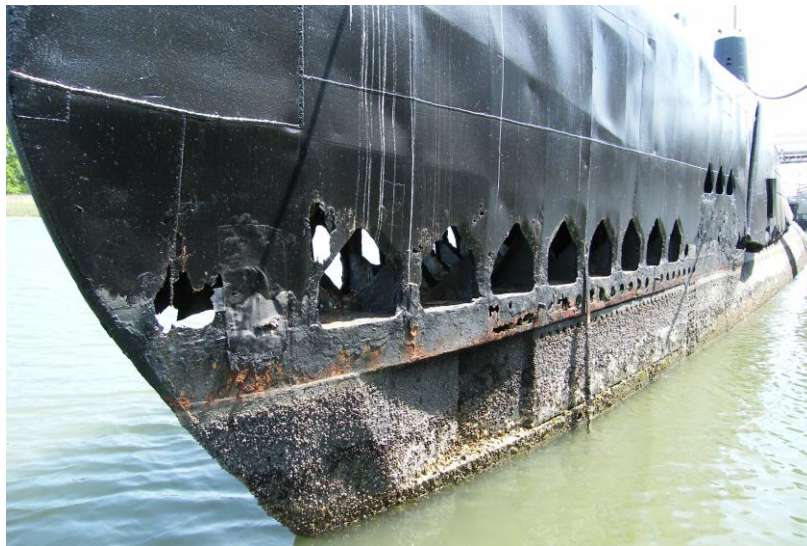
**Overall view of port bow of CLAMAGORE, showing wasted plating for superstructure fairing.**

The vessel's hull fairing forward has been intermittently immersed in standing warm salt water for many years. This has caused a failure of the vessel's paint coating system and resulting heavy rust scale of the hull plating and forward appendages. Much of the plating and structural members below the torpedo tubes is badly deteriorated and only a shipyard period can rectify this damage.

**Ascertain scope of wastage to bow framing and hull scantlings at time of drydocking, repair as needed and install sacrificial anodes.**

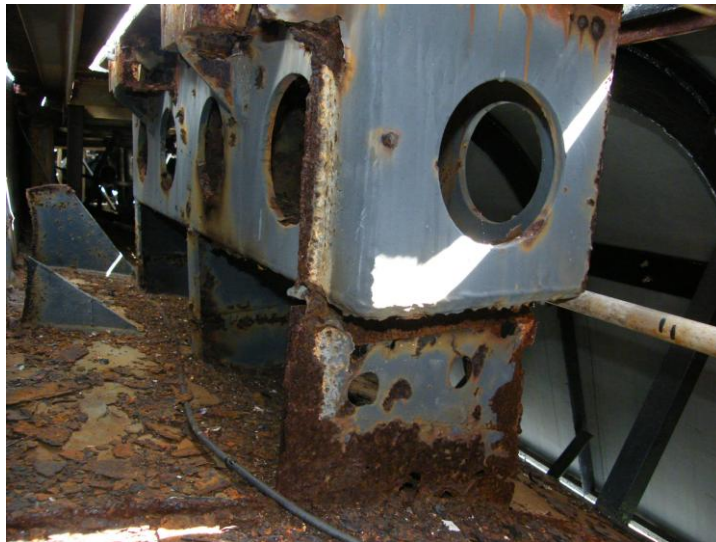
**Wasted mooring cleat foundation, typical of superstructure deck material condition.**

**Properly template and replace all mooring cleat foundations as needed, immediately.**

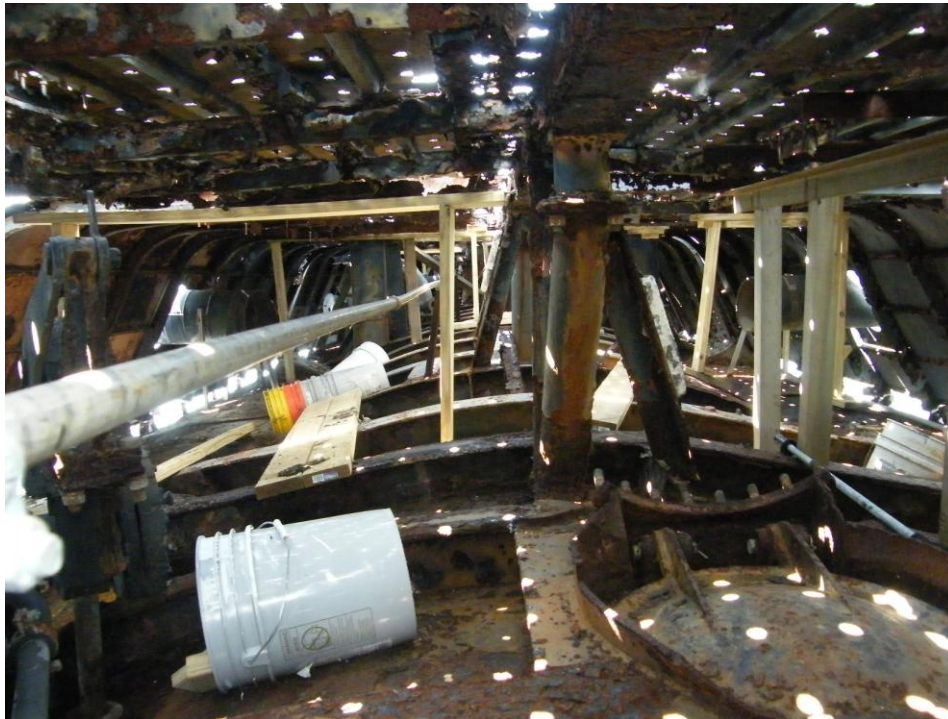
Midship area of superstructure deck being crudely supported by 2 x 4 wood planks.

**The deck between the public access paths, around the sail, and stern area is unsafe.**

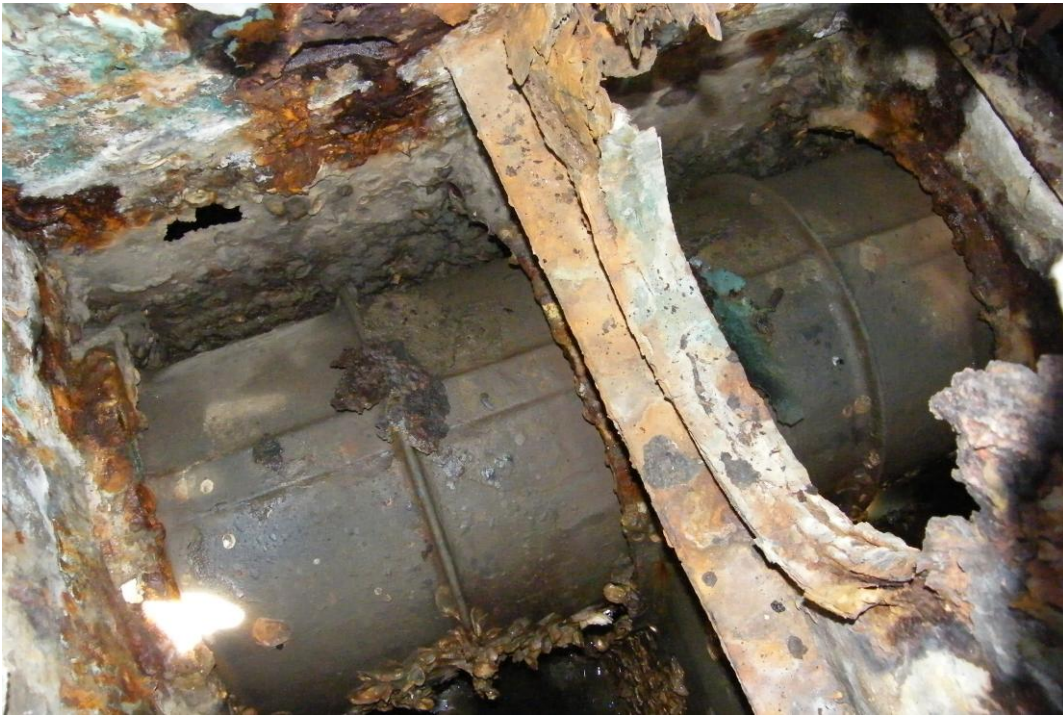
The forward and aft torpedo tubes, being of bronze construction, are causing havoc galvanically with the surrounding steel structure. Much deterioration of forward and aft structure was observed at time of survey; this will require further inspection, fabrication and repair at time of drydocking. The area aft of the sail is suffering rust/scale on the exterior because of poor drainage on top of the fuel/ballast tanks.

Wasted structure around bronze torpedo tube.

**Perform an ultrasonic inspection of the exterior fuel/ballast tankage at time of drydocking, crop out any plating with greater than 25% wastage and install new steel inserts.**

**Template, remove old wasted structure and renew with new scantlings the bow and stern fairing, foundations and shell plating around torpedo tubes.**

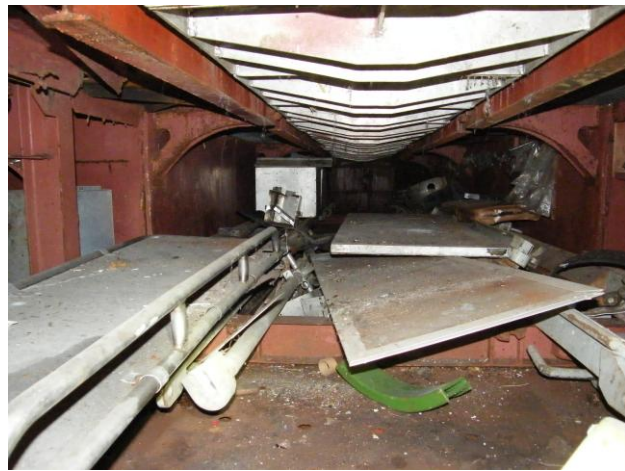
Floor under main cabin sole of Torpedo Room, showing debris and loose stowage.

- 1.) Heavily rusted and scaled under main floors over forward trim tank.
- 2.) No standing water.
- 3.) Forward torpedo tubes do not appear to be leaking.
- 4.) Well lighted.

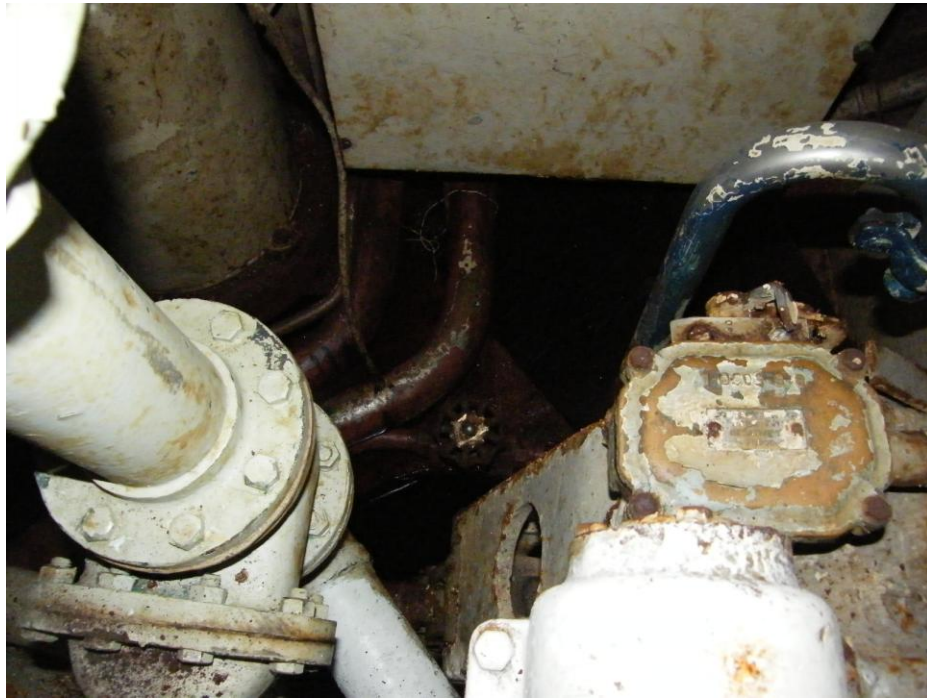
**Standing oil in Pumproom.**

- 1.) Properly seal periscopes from rainwater entry above.
- 2.) Remove and properly dispose of all standing hydraulic and lubrication oil in piping and sumps.

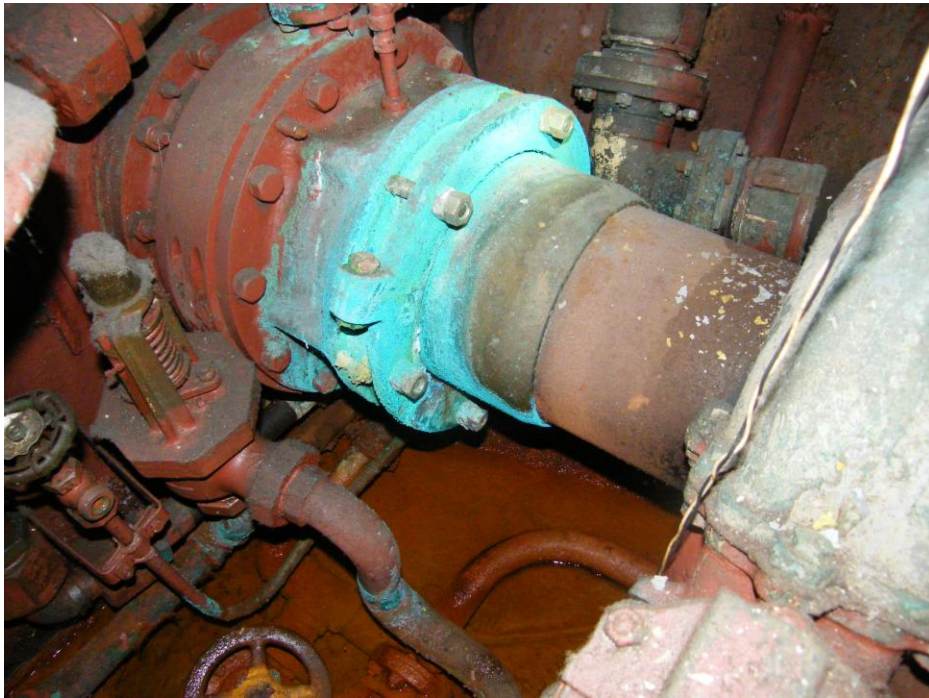
Port shaft packing gland in lower aft motor room. Showing weeping packing gland and standing water in bilges.

- 1.) **Consider installation of exterior blanking seals while vessel is in water.**
- 2.) **At time of drydocking re-pack both shaft packing glands.**
- 3.) **Lower motor room is dirty, heavy rust/scale evident, possible PCB/oil contamination.**
- 4.) **Properly de-scale, repair foundations as needed, sand, prime and paint lower space.**
- 5.) **Install proper lighting.**

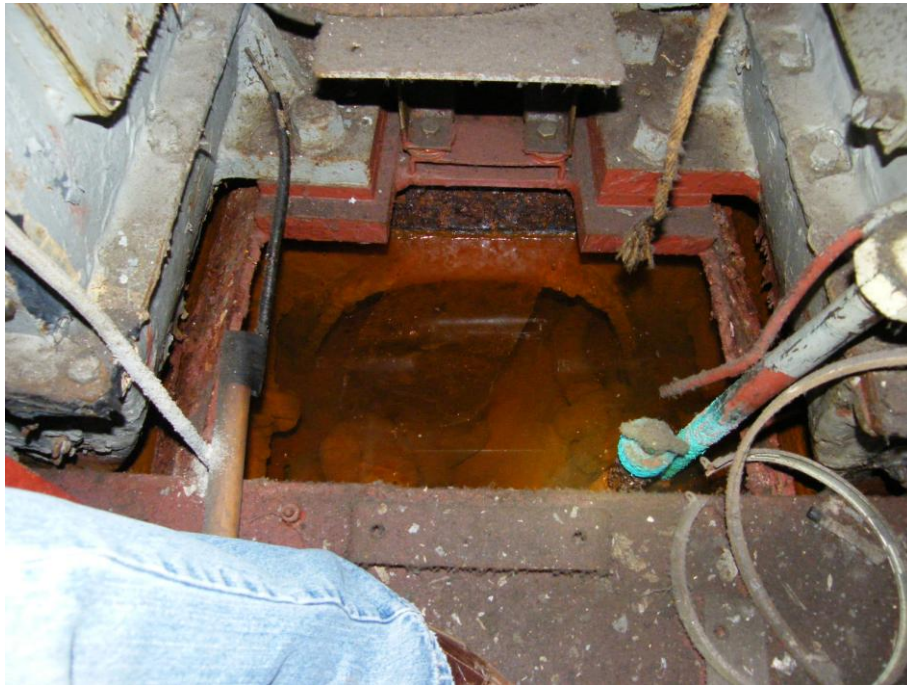
Standing water on centerline bilge of lower motor room.
