## U.S.S. CLAMAGORE (SS-343)

# Hull Survey

Vessel Survey Report No. 2344

Purpose of survey: Structural Survey

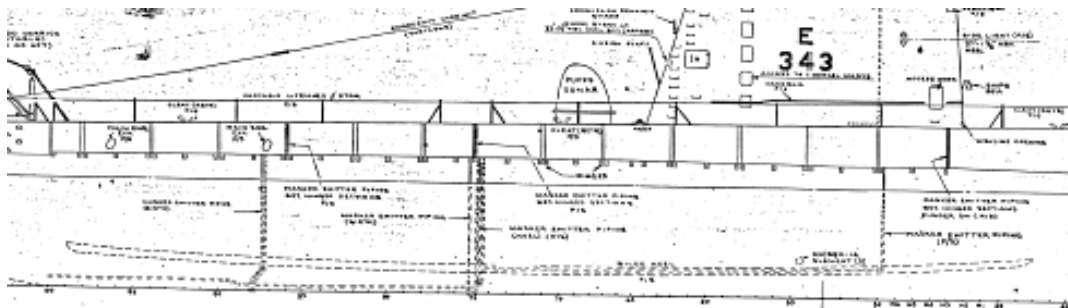
*These were not inspected at time of survey being underwater.*

Bilge keel, located at near the bottom of the hull, arc fashion.

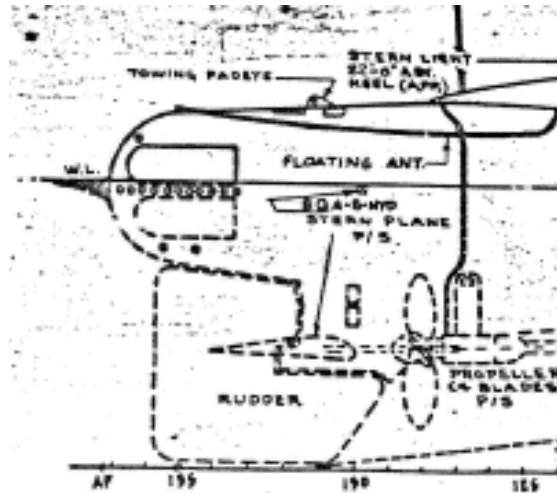
**Rudder and underwater running gear appendage adjacent to rudder.**

***The rudder (underwater) and steering appendage was not observed at the time of the survey. The rudder post and steering rams are locked in the fixed fore and aft position.***

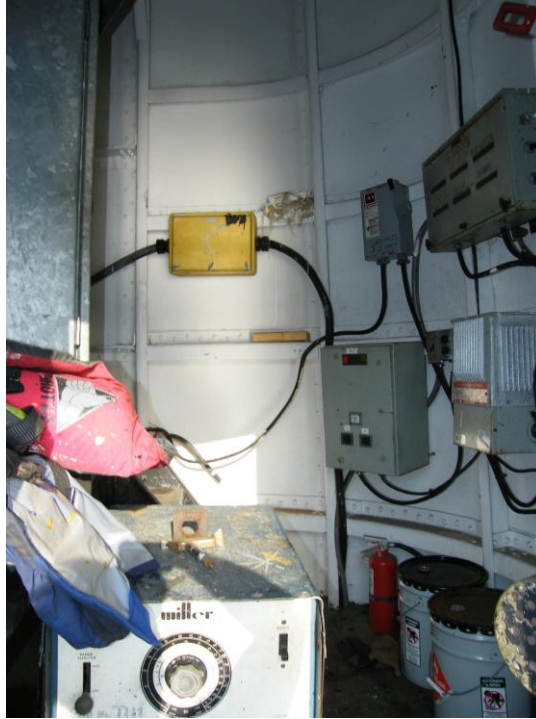
Maindeck access to sail with assorted shore power boxes and transformers.

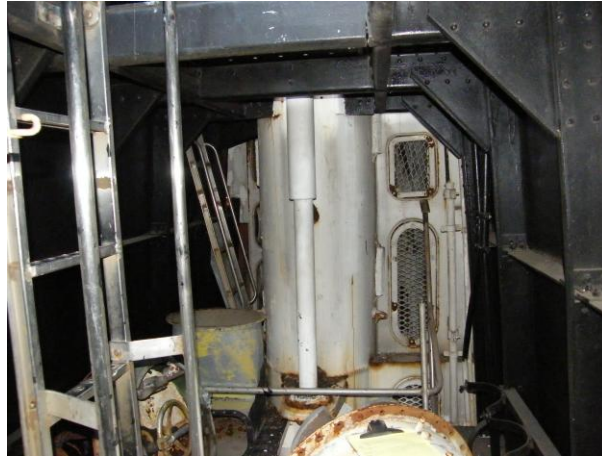
Upper flat of sail, looking aft.

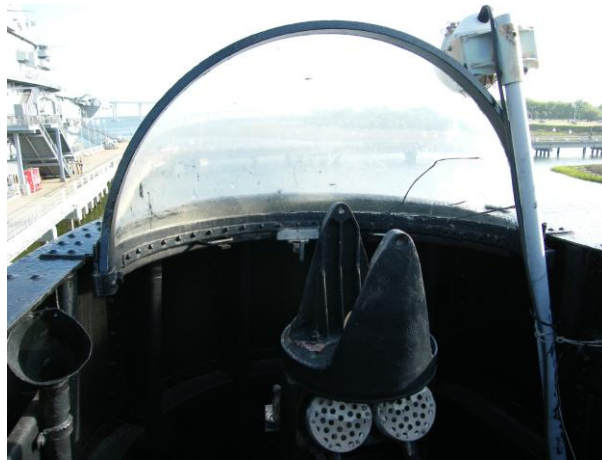
Conning station windshield.

The conning tower is designed to be a control and steering station for both submerged attack and surface cruising. This structure is in fair/good cosmetic and excellent structural shape.

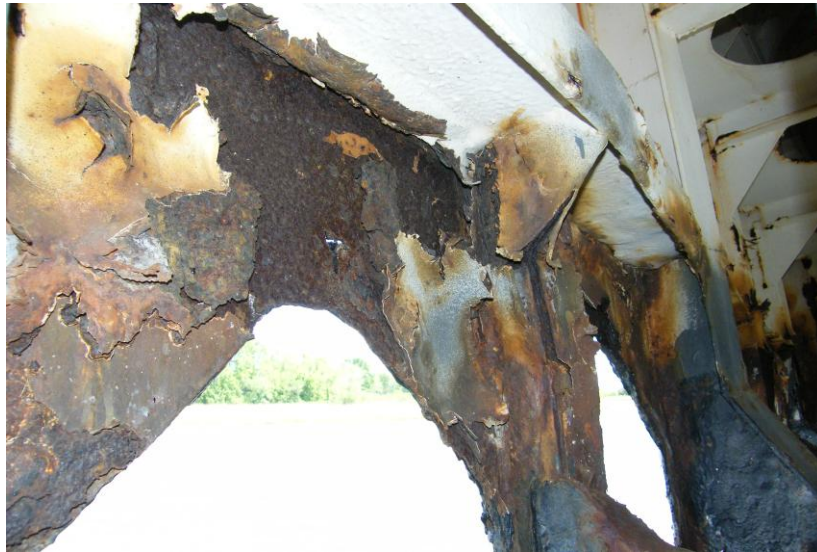
**Hull fairing at bow to starboard, looking aft.**

The vessel's hull fairing forward has been intermittently immersed in standing warm salt water for many years. This has caused a failure of the vessel's paint coating system and resulting heavy rust scale of the hull plating and forward appendages. Much of the plating and structural members below the torpedo tubes is badly deteriorated and only a shipyard period can rectify this damage.

**Ascertain scope of wastage to bow framing and hull scantlings at time of drydocking, repair as needed and install sacrificial anodes.**

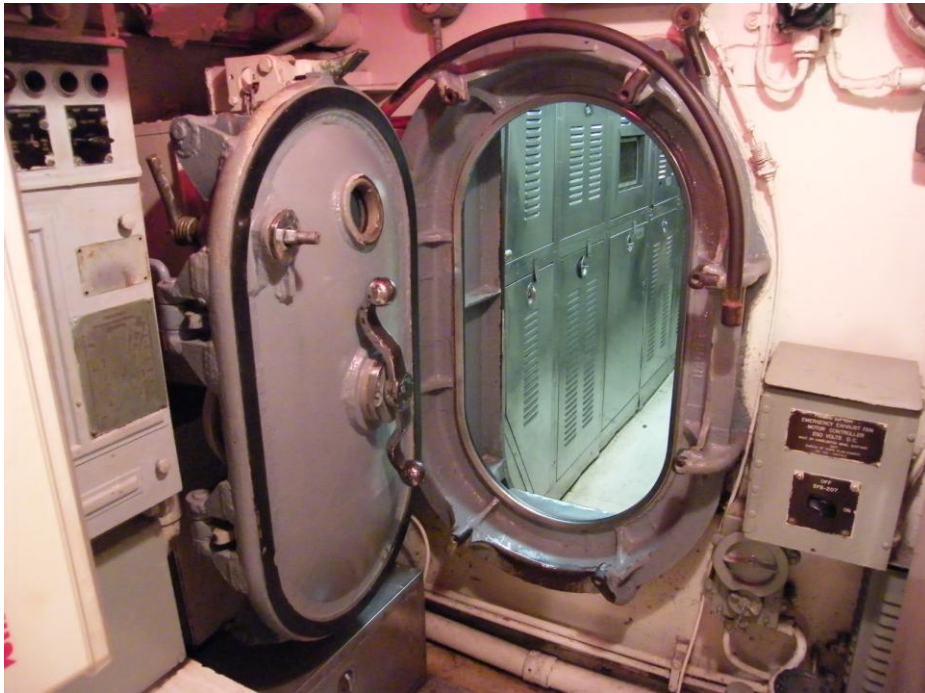
**Watertight dogging door on interior passageway.**

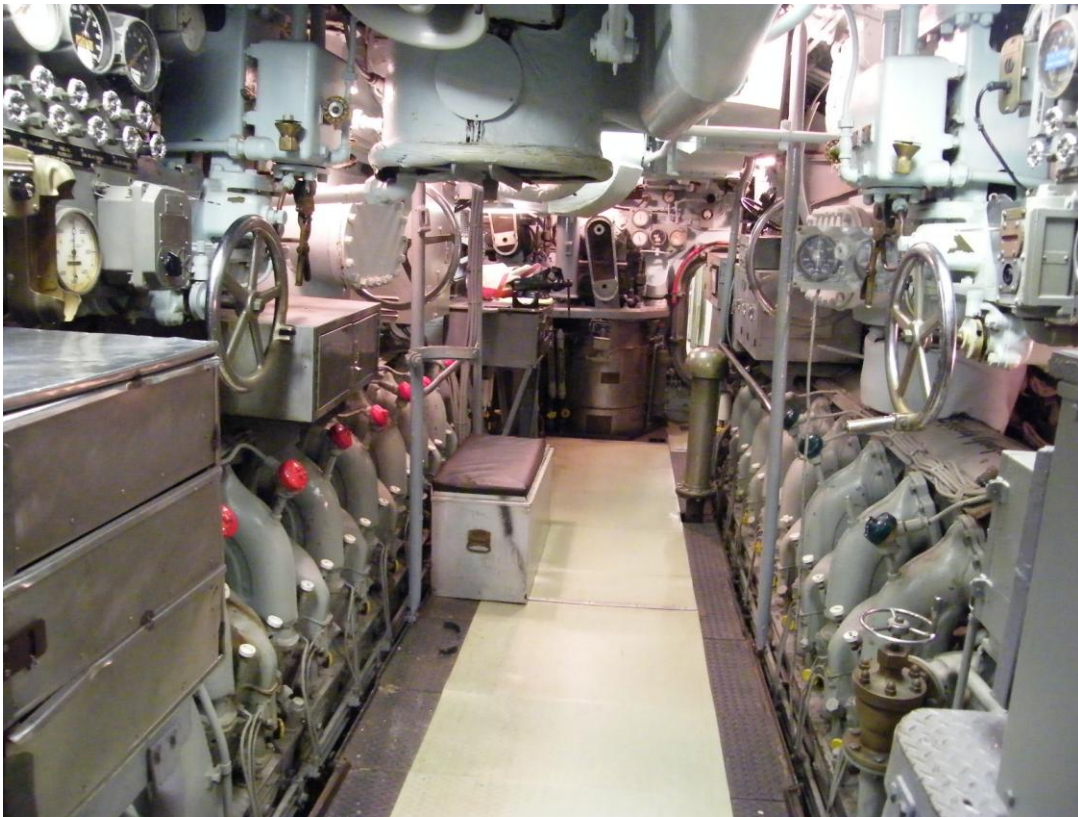
- 1.) Well lighted in upper engine room, not well lighted below.
- 2.) Upper engine room in good material and cosmetic condition.
- 3.) Lower engine room is dirty, heavy rust/scale evident, possible PCB/oil contamination.
- 4.) Some standing water/oil in bilges (3 to 4").
- 5.) Hatches to lower room needs locking devices.

Forward Engine room, looking aft..

- 1.) **Properly dispose of all standing oil from bilges and sumps.**
- 2.) **Consider cleaning, sanding and painting lower bilge space.**
- 3.) **Install proper lighting for bilge space.**

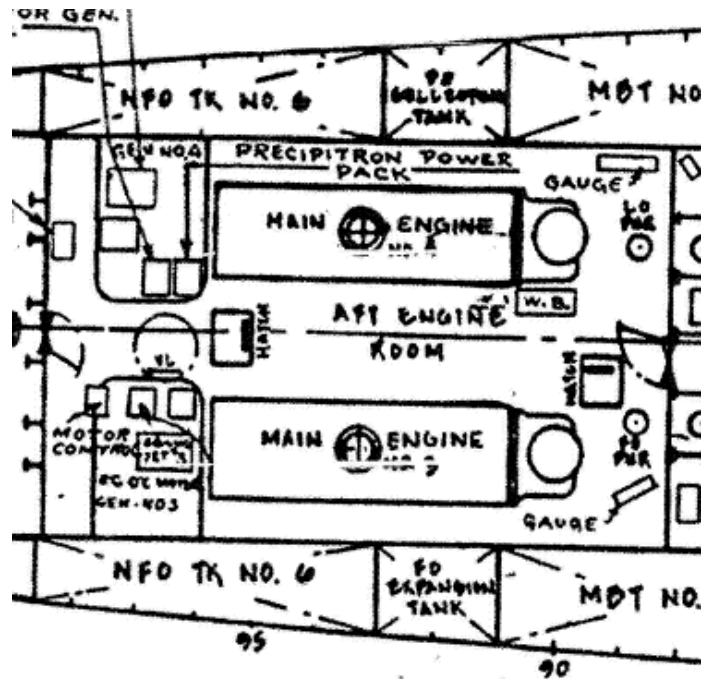
Platform Deck, After Engine room, Frames 87 1/2 to 98.

- 1.) Well lighted in upper engine room, not well lighted below.
- 2.) Upper engine room in good material and cosmetic condition.
- 3.) Lower engine room is dirty, heavy rust/scale evident, possible PCB/oil contamination.
- 4.) Some standing oil in bilges.
- 5.) Hatches to lower room needs locking devices.

- 1.) **Properly dispose of all standing oil from bilges and sumps.**
- 2.) **Consider cleaning, sanding and painting lower bilge space.**
- 3.) **Install proper lighting for bilge space.**

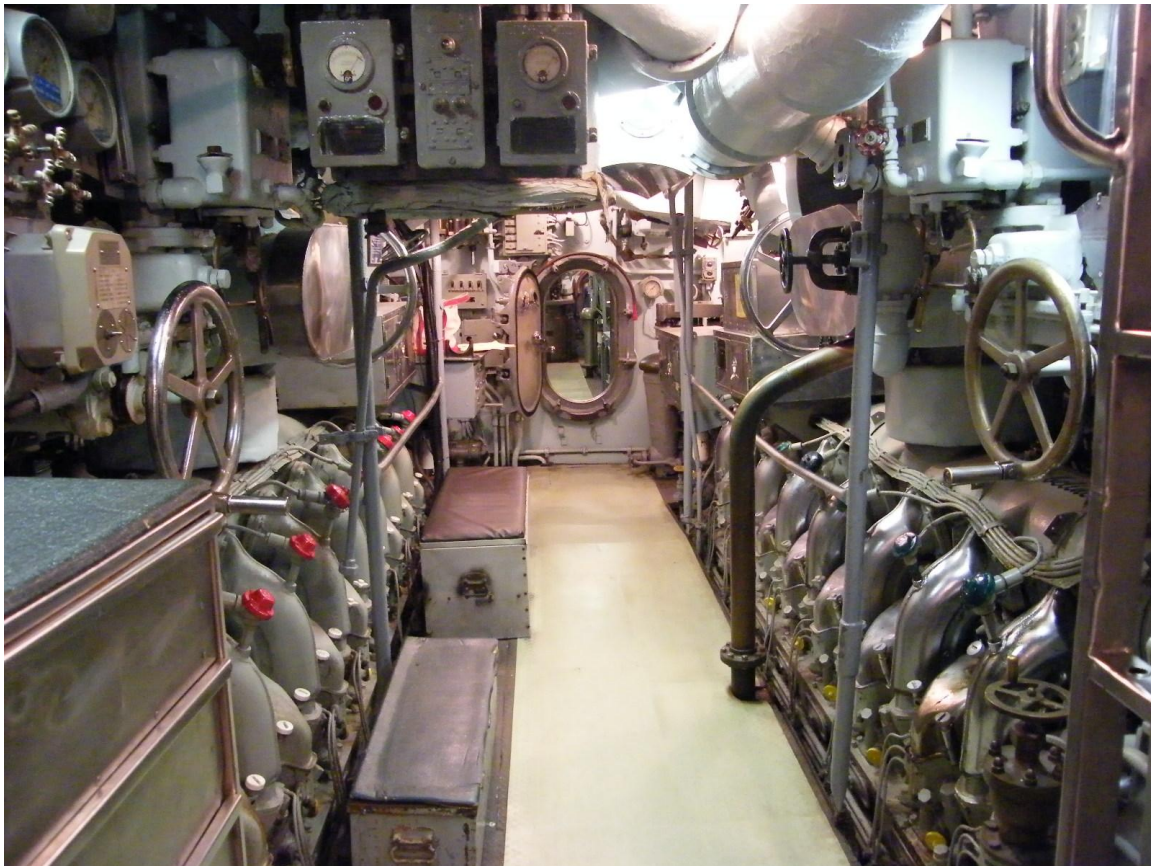
**Aft Engine room, looking aft.**

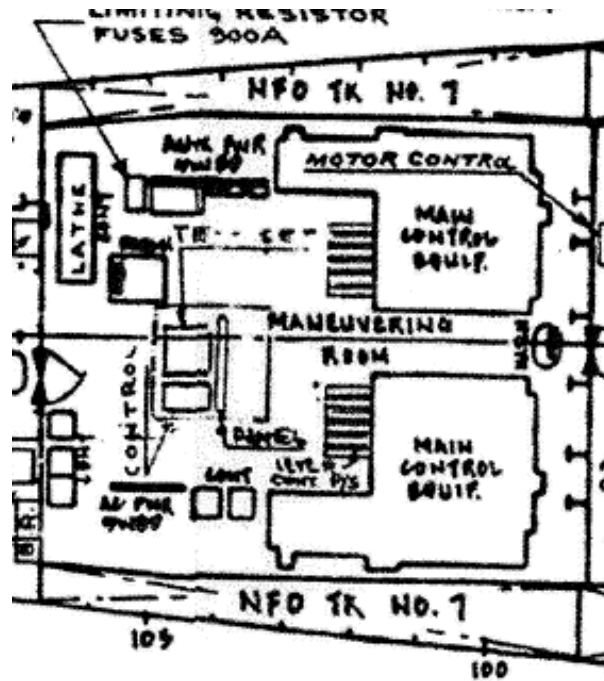
Platform Deck, Motor Control Room, Frames 98 to 108.

- 1.) Well lighted in upper room, no lighting below.
- 2.) Upper control room in good material and cosmetic condition.
- 3.) Lower motor room is dirty, heavy rust/scale evident, possible PCB/oil contamination.
- 4.) **Much standing water in bilges (12 to 18") with heavily corroded bases of bulkheads and foundations.**
- 5.) Hatches to lower room needs locking device.
- 6.) **Both shaft packing glands seeping water.**

- 1.) **Consider installation of exterior blanking seals while vessel is in water.**
- 2.) **At time of drydocking re-pack both shaft packing glands.**
- 3.) **Lower motor room is dirty, heavy rust/scale evident, possible PCB/oil contamination.**
- 4.) **Properly de-scale, repair foundations as needed, sand, prime and paint lower space.**
- 5.) **Install proper lighting.**

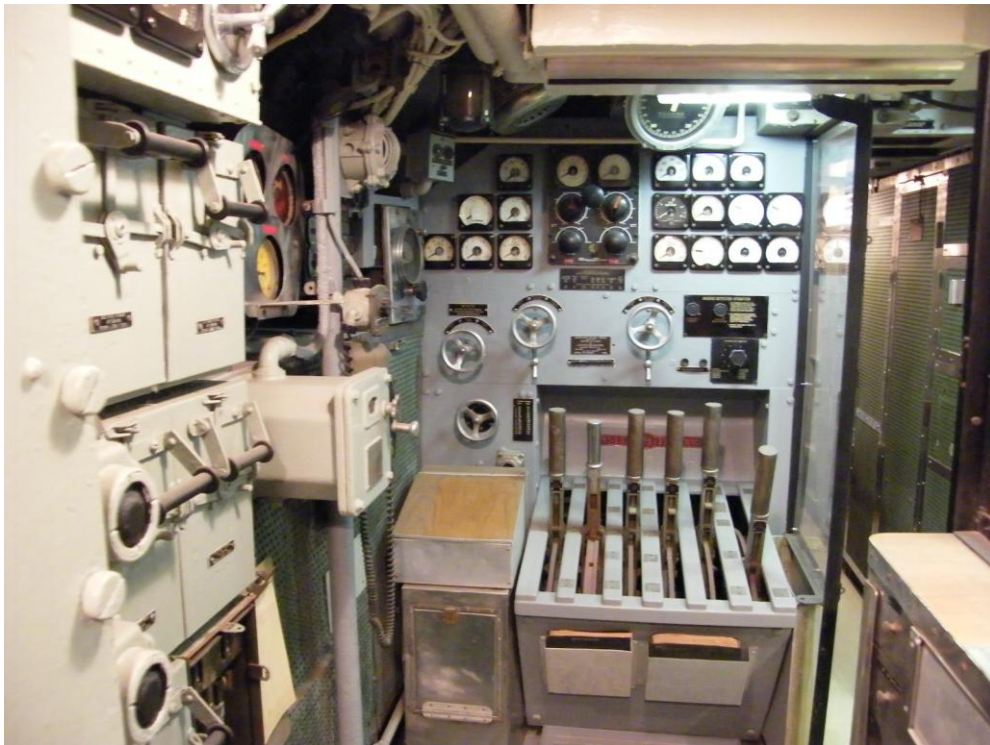
Platform Deck, Motor Control Room. Notice throttles and main panel.

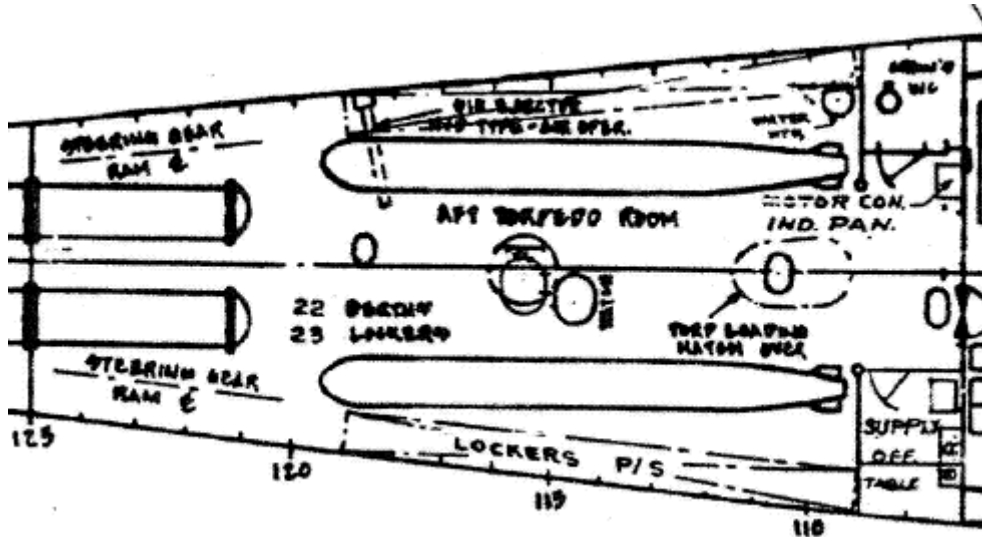
Aft Torpedo Room, Platform Deck, Frames 107 - 125.

- 1.) Heavily rusted and scaled under main floors over after trim tank.
- 2.) After torpedo tubes do not appear to be leaking.
- 3.) Well lighted.
- 4.) Deck plates need proper securing to alleviate possible trip/fall condition.

- 1.) Consider properly sealing inboard door for surface buoy tube.
- 2.) Consider properly cleaning all bilge spaces in Storeroom, properly sand, prime and paint lower bilge spaces.
- 3.) Install proper lighting for lower bilge spaces.
