PATRIOTS POINT

Development Authority
Project # P36-T007-PG

RE: Feasibility Report for the Landside Berth of the U.S.S. Clamagore

SCOPE OF SERVICES Feasibility Study for U.S.S. Clamagore

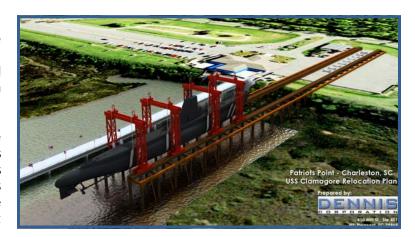
Rendering of Marine Trestle System

In order to restore and preserve this landmark, a move to dry land has been determined to be the best course of action. In order to facilitate this, a Marine Trestle System will need to be constructed to support an eight tower crane system along with the submarine itself in order to facilitate the move. A marine trestle system is similar to a pedestrian pier and is used in almost every bridge construction project for barges to shuttle supplies across a waterway. Several local contractors currently own the required steel to complete this scope of project. In addition, they would be able to salvage the steel bringing a significant cost savings to Patriots Point. In a marine trestle system, the submarine will be dead lifted out above the water using stand jacks, as opposed to a canal

inclined plane, where it is carried in a water-filled caisson. An inclined canal with rail system was originally studied, but the size of this project area did not allow enough space for the submarine to climb the embankment at the desired slope.

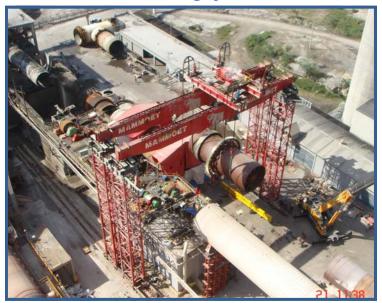
Example Tower System

Once the trestle system has been completed all wooden crane mats utilized by the pile driving equipment will be lifted, removed, and replaced with the skidding track system ready for the eight crane towers to be erected. Each crane tower will be constructed in the parking lot and will be connected making four identical systems. Strand jacks on top of the crane towers, each with a lifting capacity of 450 tons, will be used to lift the submarine directly out of the water in between the two trestle systems. The four systems will work in unison under an electrical remote control. The crane towers will then move hydraulically along a skidding track moving the submarine over existing concrete pedestal supports.

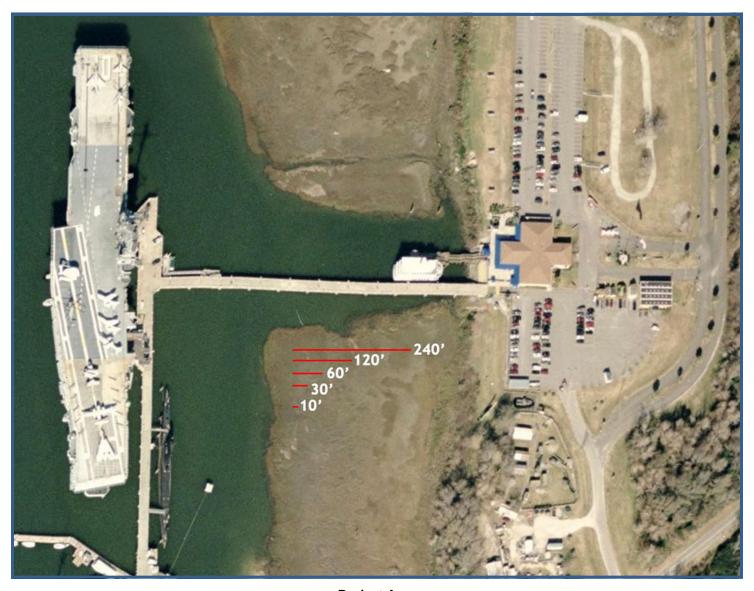
Project Area

A land and hydrographic survey was completed for this feasibility study to determine the dredging area for the U.S.S. Clamagore. This survey was used to determine calculations of the project area. In past discussions with Patriots Point officials, it was determined that the submarine still had several batteries. These batteries could weigh as much as 500 pounds each. It was additionally discussed that several of the ballast tanks are filled with water or an oil like mixture. As a result, the current estimated weight of 1,975 tons could be decreased if these remaining batteries were removed and the ballast tanks were cleaned or drained. This would in turn decrease the draft and weight of the submarine. The draft of the U.S.S. Clamagore is reported to be roughly 16 feet. In order to float the U.S.S. Clamagore and reach a minimum depth required to safely navigate the vessel, dredging below the water surface must occur. However, existing conditions and nearby pedestrian piers presented certain challenges to this step of the project. It was concluded that the required dredging had to be minimized and stay far enough away from existing piers to not disturb their foundations. Two existing piers are within the project area, both constructed with 14" concrete piles, which include batter piles driven below the surface of the water at roughly a 45 degree angle. Therefore, it was determined by members of Volkert, Inc. that the dredge centerline must be at least 75 feet away from existing pier foundations.

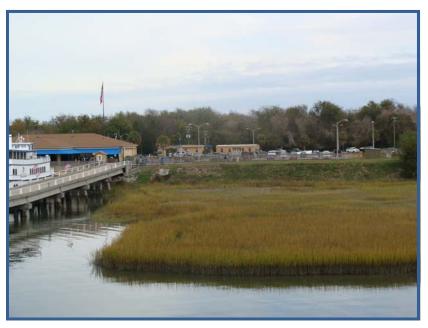
Dredging Area

Hydraulic dredging is the preferred method to reach the desired depth to float the submarine. This method of dredging and the dredging area will be almost identical for both the Crane Lift Method and the alternative Cofferdam Method. This form of dredging is done by mixing the water with the material to be removed, and pumping it away as sludge. Hydraulic dredging is more more efficient, versatile, and economical to operate our mechanical dredges, because both the digging and disposing functions are performed by one selfcontained unit in the majority of instances. Suction dredging of this type resembles a giant vacuum during its operation. A mixture of water and material is drawn through a suction pipe lowered to ground surface under water. The sludge mixture will then be discharged through a pipeline to a disposal area or onto a barge. Dredges of this type

can dig deeper than others, but are limited to soft, free flowing alluvial type material, such as the material around the U.S.S. Clamagore. For this operation we plan to use smaller portable suction dredging vessels, which will be able to fit under the existing pedestrian pier at low tide gaining access directly to the dredging area without removing any existing pier sections. A 10" swinging ladder dredge and related submerged pipeline are used in our cost estimate and have been used on previous dredging operations at Patriots Point. This will not affect museum operations. The small dredge will then pump the sludge material to a nearby vessel, which will then take the material across the Cooper River to Drum Island or 10,500' of submerged pipeline will be used to pump the material directly to the North Side of Drum Island. It is our understanding that Patriots Point currently maintains a permit to dispose of dredged material on this island, as long as the required capacity or quantities are maintained and do not exceed what is authorized.

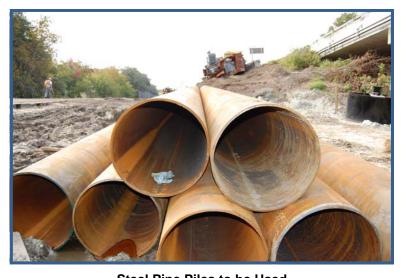
Steel Pipe Piles to be Used

Steel pipe piles are the preferred pile type for this project for many reasons. They are very durable and resistant to corrosion. They are ideal for marine conditions and they can be driven in loose material to high depths. The use of steel pipe piles gives you inside and outside friction resistance, which will make them stronger to support the load weights and less likely to move while driving nearby pipe piles. One of the greatest advantages to the use of steel pipe piles is that they can be removed by vibrating them loose from the bottom layer of Cooper Marl and reused by the contractor. This provides a salvaging price for Patriots Point. Ultimately Patriots Point will not be responsible for purchasing any of the steel for this method because the majority of local marine contractors already have the same materials in their yards to construct such a trestle. This type of trestle is used on almost every bridge construction job to transport materials by crane around the job site.

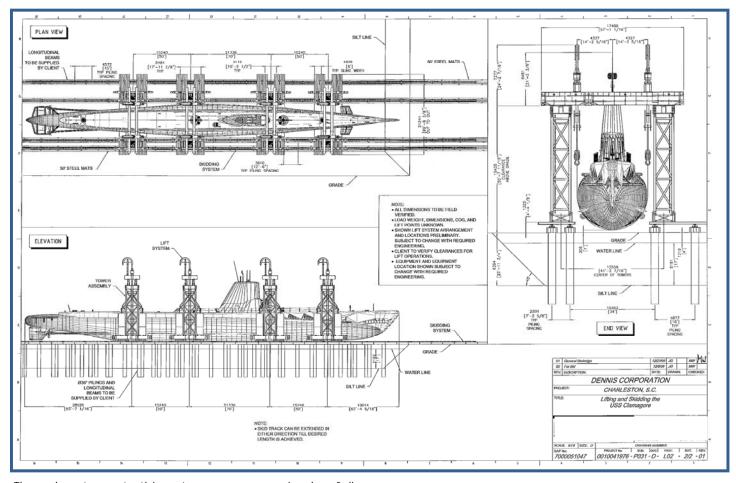
As seen in the End View in the graphic shown below, multiple strand jack units will be required to fully distribute the weight of the vessel. The system has the advantage, due to its geometry, of lifting the Clamagore above finished grade to facilitate the movement of the vessel to its intended final location. As noted above, the units are computer controlled and crane tower systems will operate simultaneously as a continuous operation.

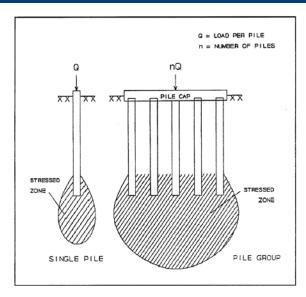
Based on their review of the laboratory work and field work, S&ME recommended the use of driven H-pile and open-ended pipe piles. Pile driving is accomplished using a mechanical device that physically hammers piles into soil to depths such that support capacity for the applied loading is achieved. Diesel pile hammers are typically used for the installation of these types of steel pile supports. The system consists of a large two-stroke diesel engine attached to a piston providing the driving weight of the hammer. The pile driving operation begins when the crane operator raises the piston using cabling supporting the pile driver which draws air into the engine cylinder. The weight is dropped using a quick-release device and the piston's weight compresses air in the hammer cylinder instantaneously, producing tremendous heating that provides ignition of the diesel fuel. Diesel fuel is continually injected into the cylinder. Each time the falling weight strikes the pile head, engine ignition drives the weight back up, again drawing in more fuel-air mixture, and the cycle starts over until the fuel runs out or is stopped by the pile crew.

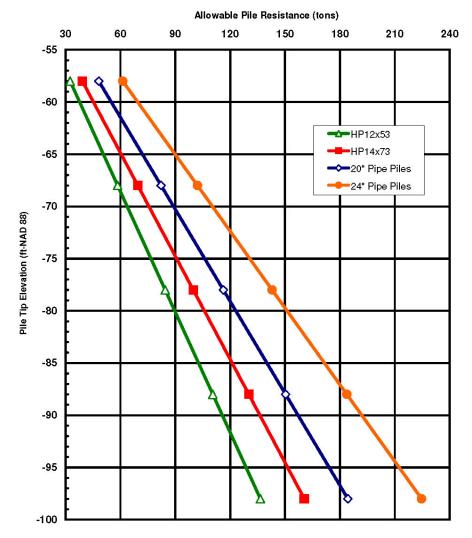
S&ME developed a capacity versus depth chart as shown here assuming adequate pile spacing for several pile types. This chart provides the flexibility to assess pile configurations, types, and loading conditions and help quickly determine the most economical foundation type for design. Using the component loading for the two and three-pile bent scenarios, pile types were investigated. Since the pile load range for the two bent types is between 160 and 240 tons at unfactored, service load conditions, it is determined from the chart that the HP 12, HP 14, and 20inch pipe piles would not be appropriate pile sections due to the extensive length required to achieve axial capacity. The 24-inch and 36-inch piles can be installed at these load capacities at a more reasonable depth. A two-pile bent would require approximately 105 feet of 36-inch pipe pile to achieve the 240 ton capacity, assuming the top elevation of the pile to be approximately elevation 25 feet. For a three-pile arrangement using 24-inch diameter pipe piles at 160 tons, each pile would need to be approximately 105 feet as well. The final tip elevation of the installed piles will approximately at elevation -80 feet.

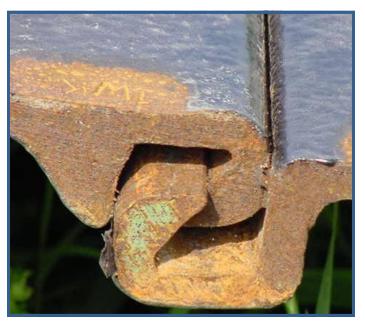
"AZ" Sheet Piling- Notice the joint is shaped like an "A"

For this method application, "AZ" pile would be preferable. "Z" shaped piles are considered one of the most efficient piles available. "Z" piles have their interlocks located at the outer fibers of the wall, assuring the designer of their published section modulus. Available styles of "Z" piles are "AZ" and "PZ". The "PZ" piling is produced with a ball and socket interlock system. The ball and socket is flexible upon setting, yet is extremely durable under driving conditions. For this application, we feel that a rigid application is warranted and therefore recommend the "AZ" pile. The "AZ" pile joint has flat a-shaped connections that do not allow flexibility in the joint thereby further securing the joint. The piles would be hot rolled into shape at a mill and shipped to the site for installation by an excavator mounted vibratory hammer. This method is nearly twice as efficient as the conventional driving method. Steel I-beams will be driven first to guide the driving of the walls and further support the sheet piling. Cross bracing of the I-beams in several locations with horizontal beams will be used as a driving template. The sheet piling would need to

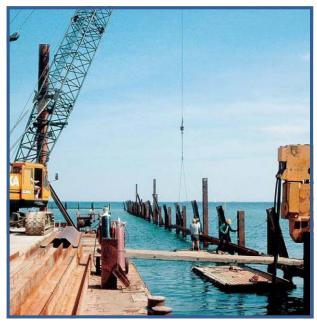
The crane is used to install the supporting l-beams.

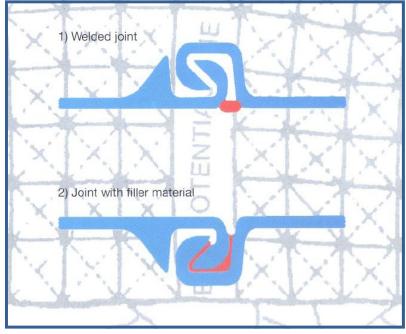
"AZ" Pilings Welding v/s Filler.

Welding options.

This structure will need to be impervious to water so an interlock sealing system will be used to keep water out. The steel sheets are completely impervious and the only possible route for breach is through the joints. A bituminous filler material is the simplest and most cost effective method for sealing the joints. Bituminous filler is composed of a tar compound, asphalt, or a mixture of the two. This filler is hot fed into the sheet pile interlocks either at the factory or on site. Petrochemicals may have a negative impact on the durability of the bituminous filling system. In application of the bituminous filler, care must be taken to make sure the joints are dry before the filler is installed. For this particular application, this method will be rejected for that reason. A water-swelling filler system may be used in lieu of the bituminous filler. The water-swelling product expands in water and seals the joints between the sheet piles thereby creating an impervious structure. This system is effective up to twenty five meters of water pressure and possesses excellent durability for fresh and sea water environments as

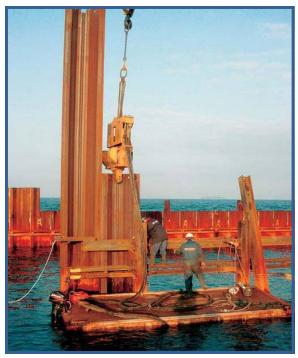
A crane is used to direct long pilings.

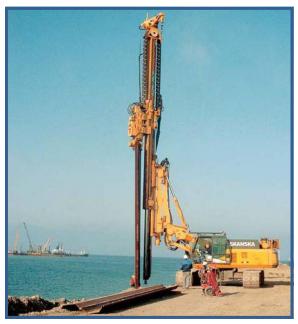
Excavator Mounted Vibratory Hammer (EMVH) emplacing support rods.

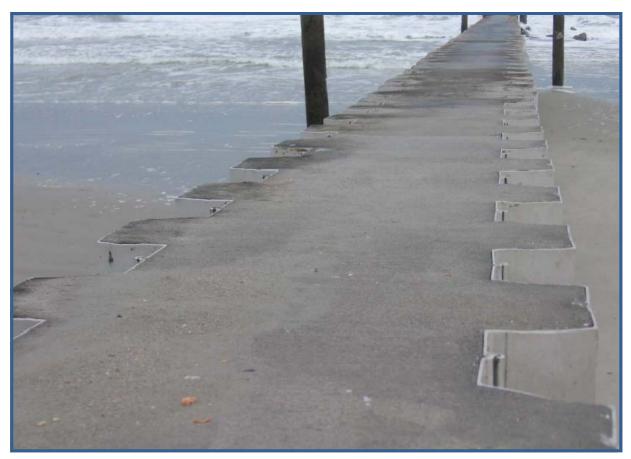
"PZ" Sheet Piling Retaining Wall

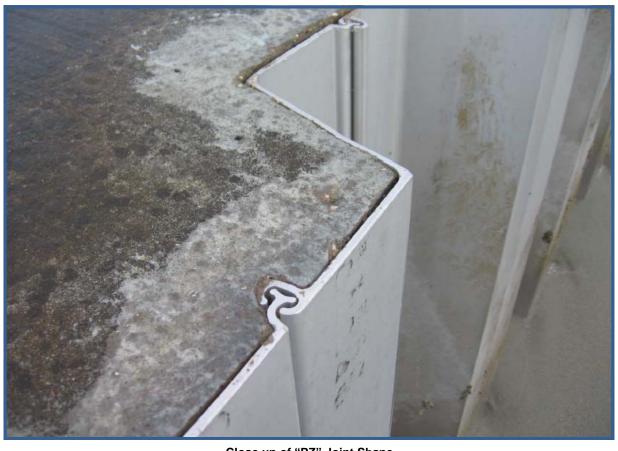
Close up of "PZ" Joint Shape

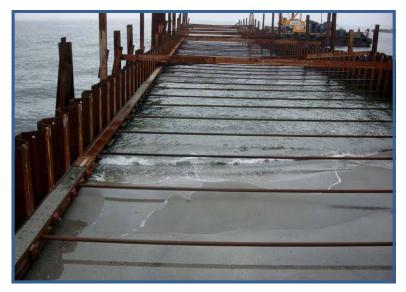
Tie Rods between the sheet piling walls

A schematic example of a sheet pile wall

be anchored as this wall would be considerably high. Support braces will be welded to the walls to connect the tie rods. The upper tie rod and brace may be welded by conventional welding methods and the lower tie rod will be welded by divers once the sheet piles are driven.

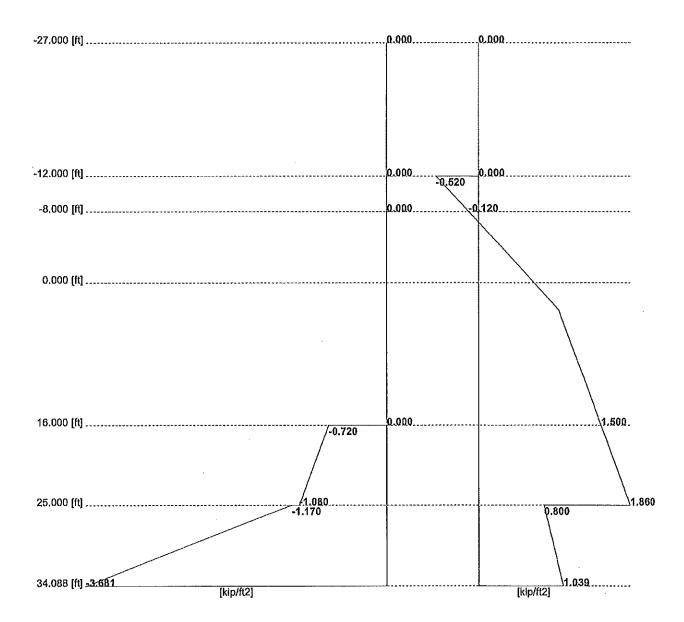
Earth Pressure Diagram

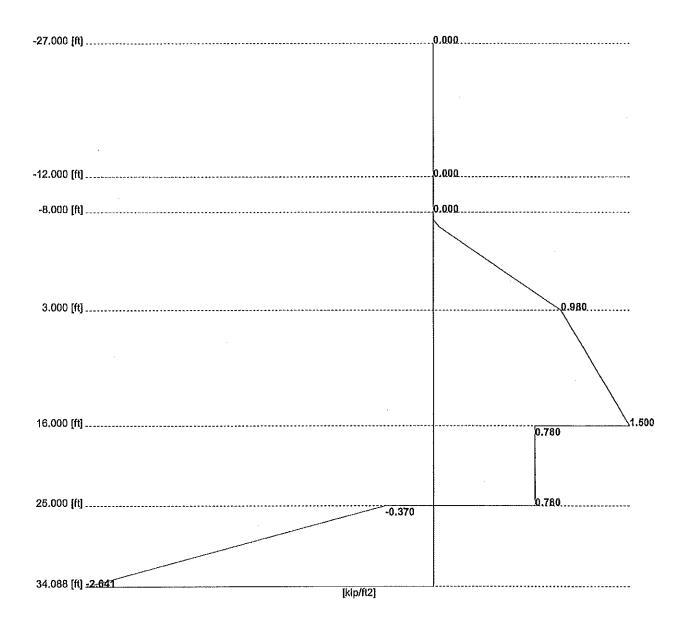
Total Pressure Diagram

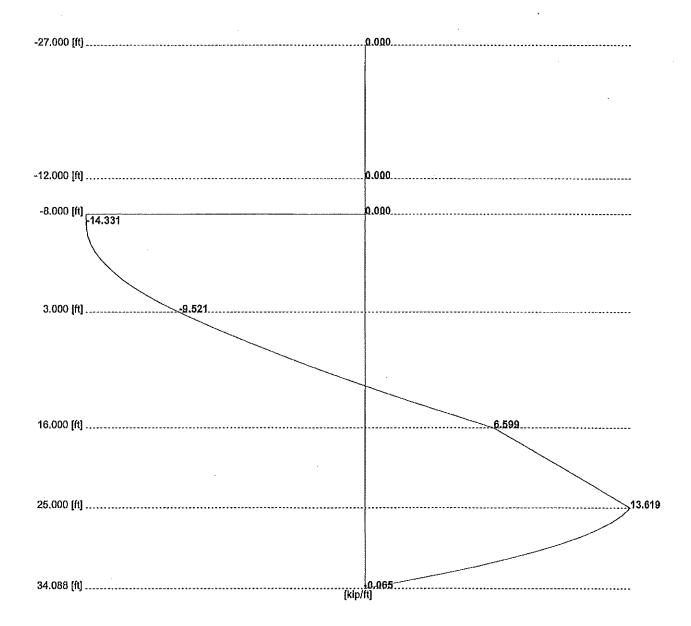
Cross Force Diagram

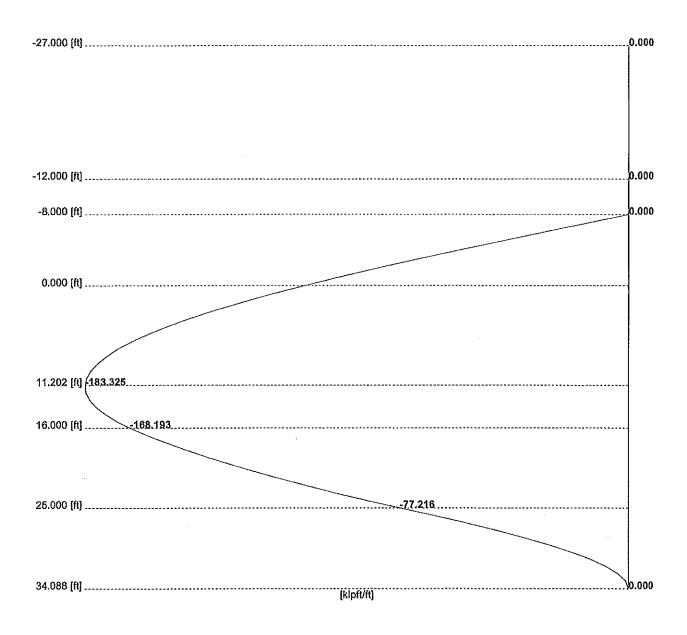
Moment Diagram

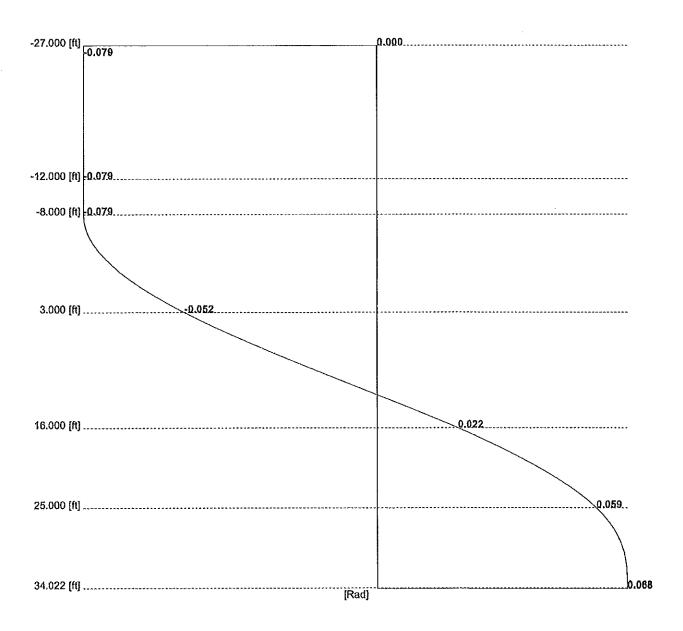
Rotation Diagram

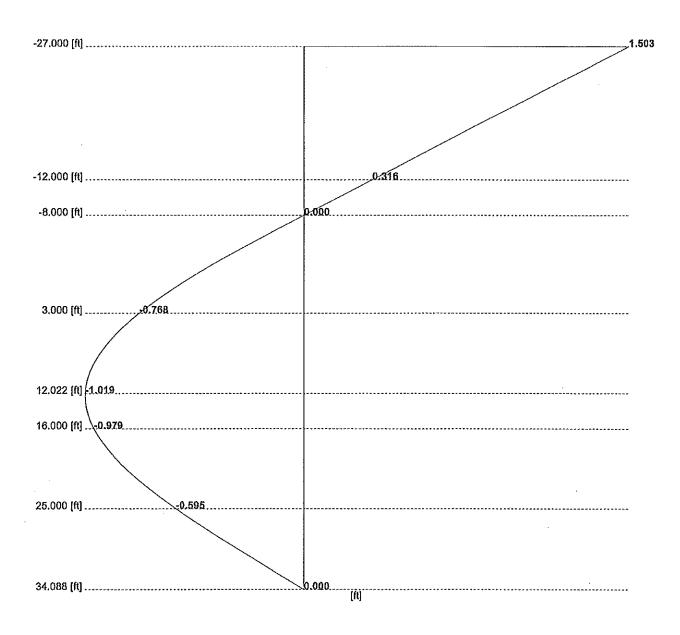
Deflection Diagram

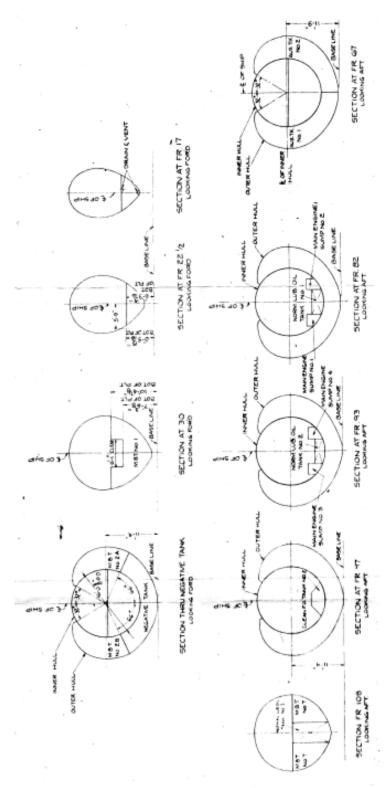
Hull sections for CLAMAGORE.

The thick-skinned boats came along in 1942 with a test depth of 412 feet. These boats had the same seven eighths inch thick hull as Salmon, but the quality of hull steel ie., high tensile strength steel had significantly improved. The crush depth of these boats was estimated to be around 450 feet. Fleet type submarines built during the Second World War were to last through much of the cold war. These boats have careers that have lasted over fifty years with several still being used by foreign navies.

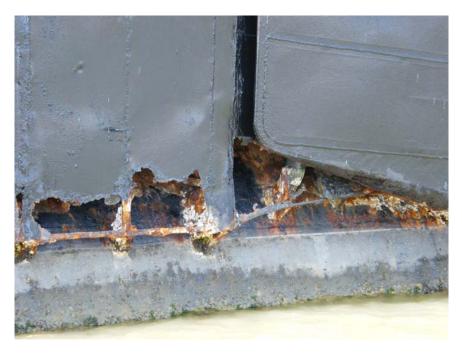
Detail of forward plane to starboard, showing wasted superstructure deck framing and face plating.

The two bow planes appear to be in fair condition in that the hinges for both planes (what is visible) appear in tough condition. The foundations/bases for these planes are deteriorating badly. Additional reinforcement will be needed. There is interior degradation of the planes with wastage holes at the bottoms of both planes.

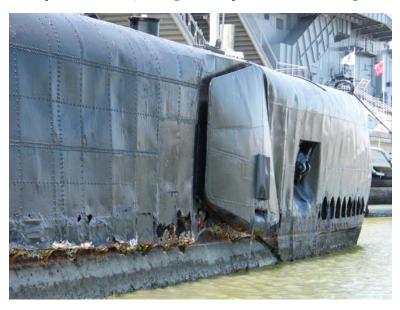
Forward plane to starboard, showing wasted superstructure deck framing and face plating.

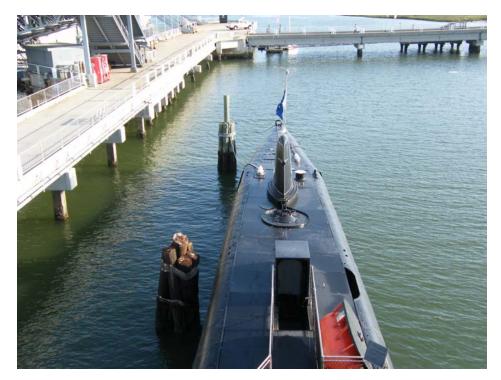
Foredeck profile, showing area forward of the sail.

The superstructure or main deck is attached to the exterior hull by means of the framing and rounded sides forward and aft. Limber holes in the sides allow sea water to enter all the hollow spaces in the superstructure and the deck when diving, and drain off when the submarine is surfaced. The sonar dome is fitted forward followed by the tapered portion of the pressure hull gradually flaring to the full width pressure hull aft.

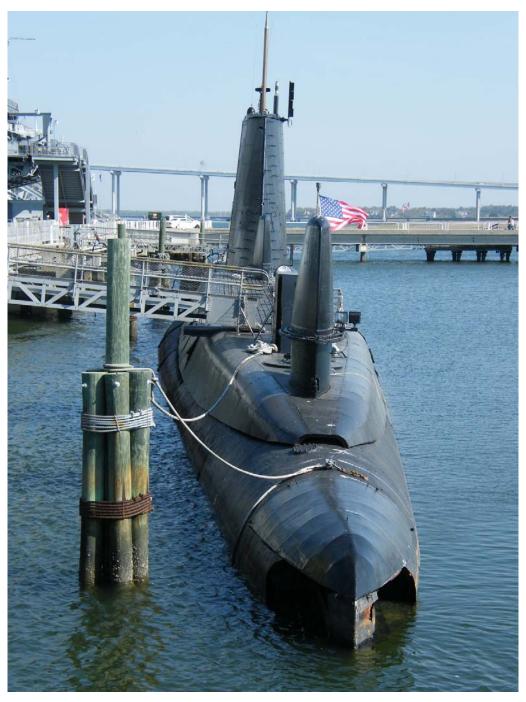
Maindeck, aft, looking toward stern tubes.

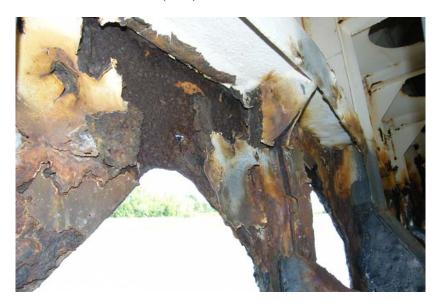
Hull fairing at bow to starboard, looking aft.

The vessel's hull fairing forward has been intermittently immersed in standing warm salt water for many years. This has caused a failure of the vessel's paint coating system and resulting heavy rust scale of the hull plating and forward appendages. Much of the plating and structural members below the torpedo tubes is badly deteriorated and only a shipyard period can rectify this damage.

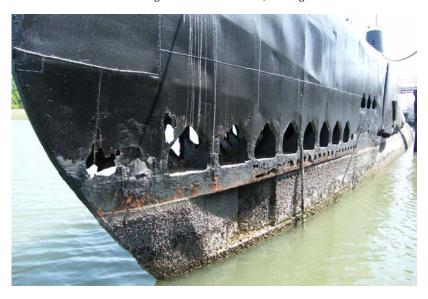
Overall view of port bow of CLAMAGORE, showing wasted plating for superstructure fairing.

Ascertain scope of wastage to bow framing and hull scantlings at time of drydocking, repair as needed and install sacrificial anodes.

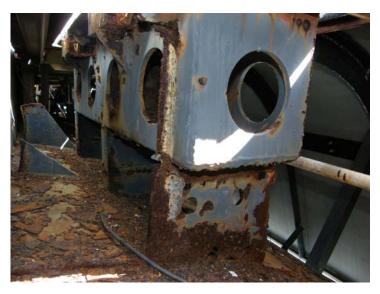
Wasted mooring cleat foundation, typical of superstructure deck material condition.

Properly template and replace all mooring cleat foundations as needed, immediately.

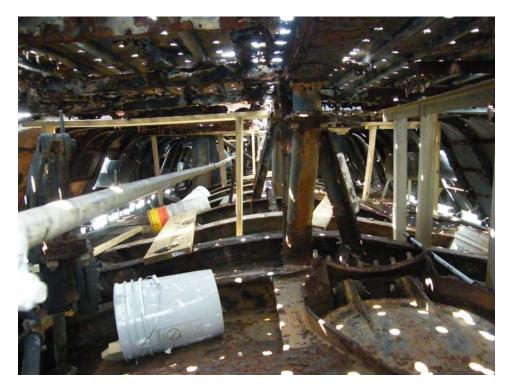
Midship area of superstructure deck being crudely supported by 2 x 4 wood planks.

The superstructure deck forward and aft of the sail is in exceedingly poor condition. Much of the support foundation is rotted away with a crude attempt to strengthen the deck by the installation of wooden 4 x 4 and 2 x 4 planks.

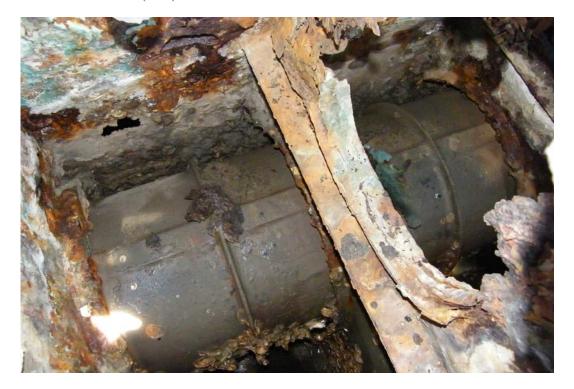
Wasted structure around bronze torpedo tube.

The forward and aft torpedo tubes, being of bronze construction, are causing havoc galvanically with the surrounding steel structure. Much deterioration of forward and aft structure was observed at time of survey; this will require further inspection, fabrication and repair at time of drydocking. The area aft of the sail is suffering rust/scale on the exterior because of poor drainage on top of the fuel/ballast tanks.

Template, remove old wasted structure and renew with new scantlings the bow and stern fairing, foundations and shell plating around torpedo tubes.

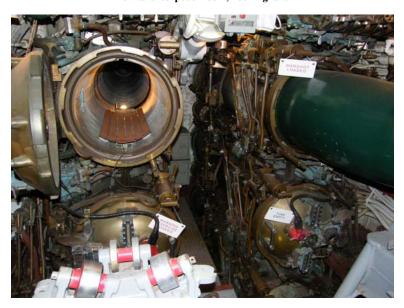
Forward torpedo tubes.

- 1.) Heavily rusted and scaled under main floors over forward trim tank.
- 2.) No standing water.
- 3.) Forward torpedo tubes do not appear to be leaking.
- 4.) Well lighted.
- 1.) Renew transverse floor panels, several are loose, deteriorated and are in need of replacement.
- 2.) Replace loose of missing floor tiles.

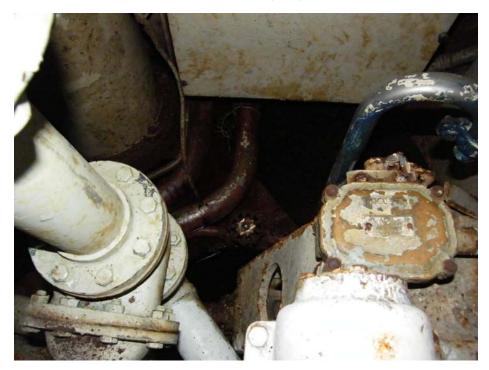
Standing oil in Pumproom.

2.) Remove and properly dispose of all standing hydraulic and lubrication oil in piping and sumps.

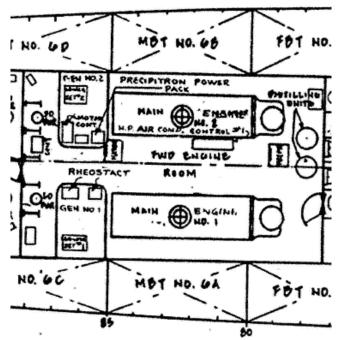
Platform, Forward Engineroom, Frames 77 ½ to 88.

- 1.) Well lighted in upper engineroom, not well lighted below.
- 2.) Upper engineroom in good material and cosmetic condition.
- 3.) Lower engineroom is dirty, heavy rust/scale evident, possible PCB/oil contamination.
- 4.) Some standing water/oil in bilges (3 to 4").
- 5.) Hatches to lower room needs locking devices.

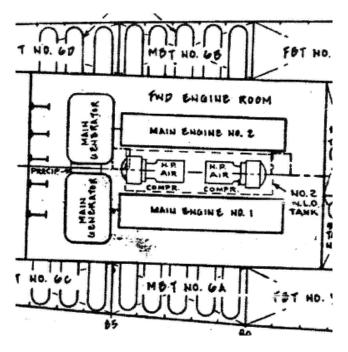
Hold, Forward Engineroom, Frames $77\, \frac{1}{2}$ to 88.

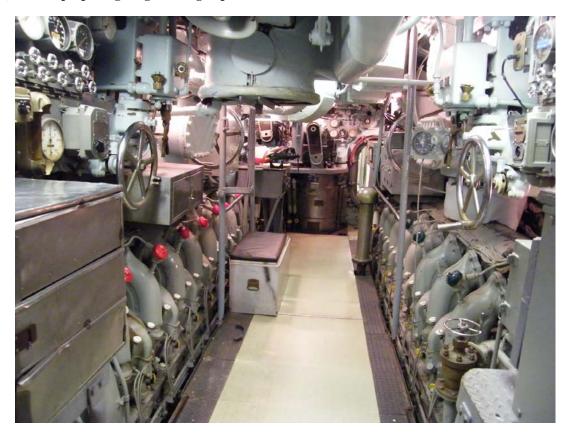
Forward Engineroom, looking aft..

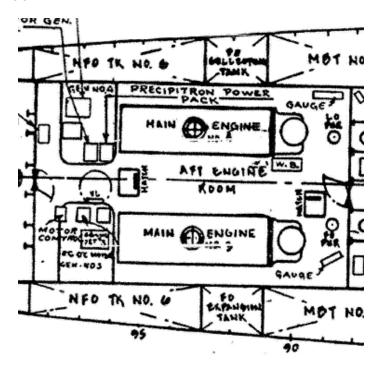
Platform Deck, After Engineroom, Frames $87 \frac{1}{2}$ to 98.

- 1.) Well lighted in upper engineroom, not well lighted below.
- 2.) Upper engineroom in good material and cosmetic condition.
- 3.) Lower engineroom is dirty, heavy rust/scale evident, possible PCB/oil contamination.
- 4.) Some standing oil in bilges.
- 5.) Hatches to lower room needs locking devices.

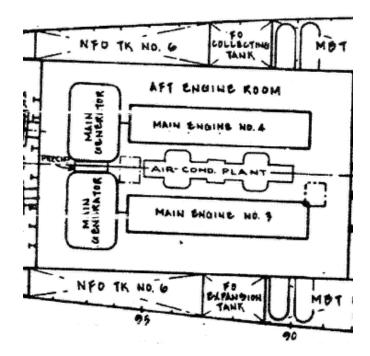
Hold, After Engineroom, Frames $87 \frac{1}{2}$ to 98.

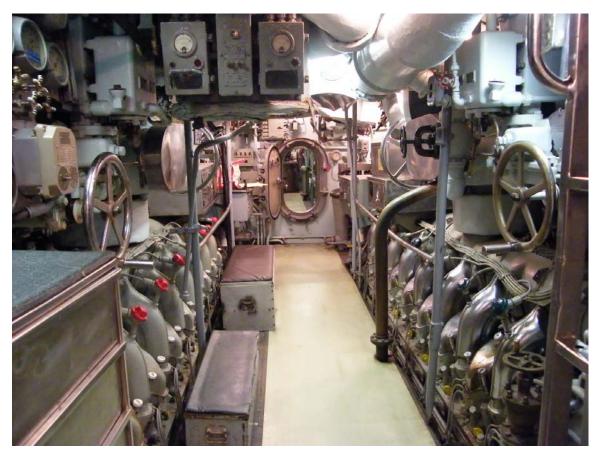
Aft Engineroom, looking aft.

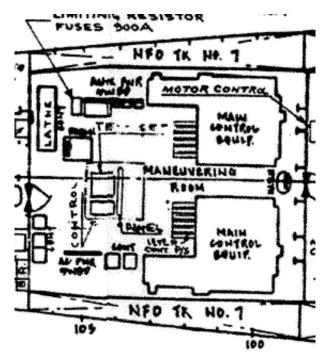
Platform Deck, Motor Control Room, Frames 98 to 108.

- 1.) Well lighted in upper room, no lighting below.
- 2.) Upper control room in good material and cosmetic condition.
- 3.) Lower motor room is dirty, heavy rust/scale evident, possible PCB/oil contamination.
- 4.) Much standing water in bilges (12 to 18") with heavily corroded bases of bulkheads and foundations.
- 5.) Hatches to lower room needs locking device.
- 6.) Both shaft packing glands seeping water.

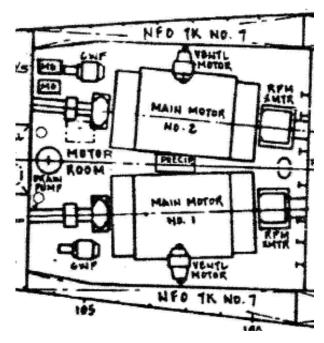
Hold, Motor Control Room, Frames 98 to 108.

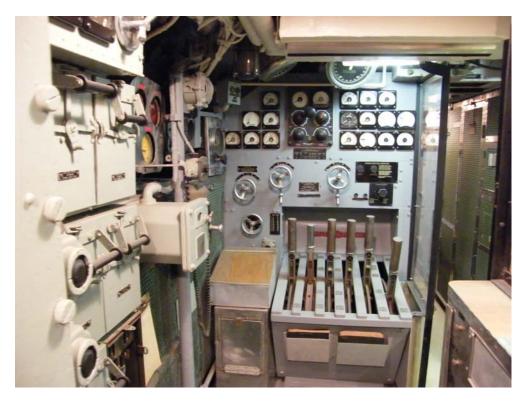
Platform Deck, Motor Control Room. Notice throttles and main panel.

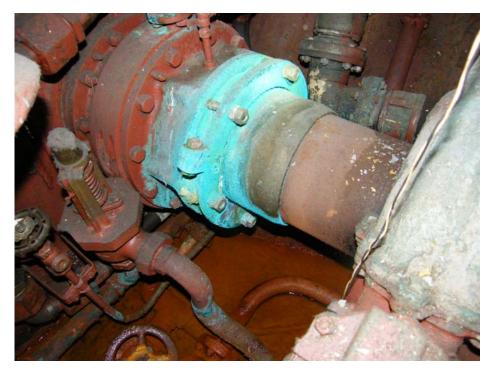
Port shaft packing gland in lower aft motor room. Showing weeping packing gland and standing water in bilges.

- 1.) Consider installation of exterior blanking seals while vessel is in water.
- 2.) At time of drydocking re-pack both shaft packing glands.
- 3.) Lower motor room is dirty, heavy rust/scale evident, possible PCB/oil contamination.
- 4.) Properly de-scale, repair foundations as needed, sand, prime and paint lower space.
- 5.) Install proper lighting.

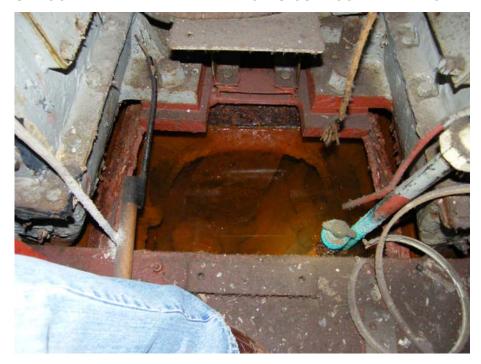
Standing water on centerline bilge of lower motor room.

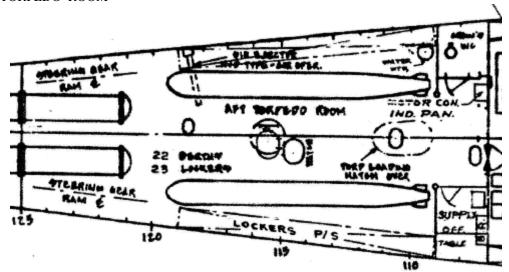
Aft Torpedo Room, Platform Deck, Frames 107 - 125.

- 1.) Heavily rusted and scaled under main floors over after trim tank.
- 2.) After torpedo tubes do not appear to be leaking.
- 3.) Well lighted.
- 4.) Deck plates need proper securing to alleviate possible trip/fall condition.

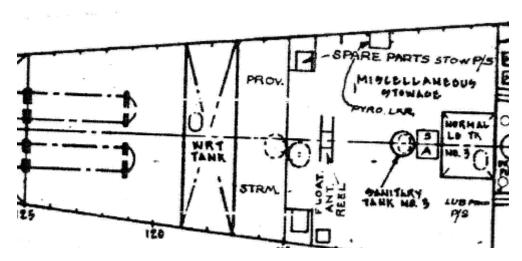
Aft Torpedo Room, Hold, Frames 107 - 125

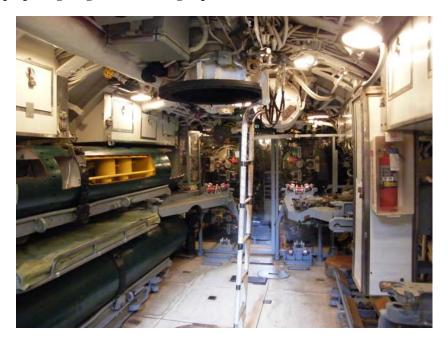
Aft Torpedo Room, looking aft.

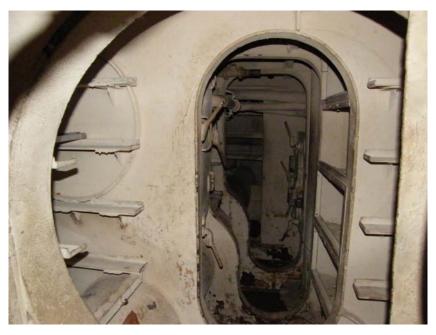
Hold, Storeroom, formerly tank #7.

- 1.) Consider properly sealing inboard door for surface buoy tube.
- 2.) Consider properly cleaning all bilge spaces in Storeroom, properly sand, prime and paint lower bilge spaces.
- 3.) Install proper lighting for lower bilge spaces.

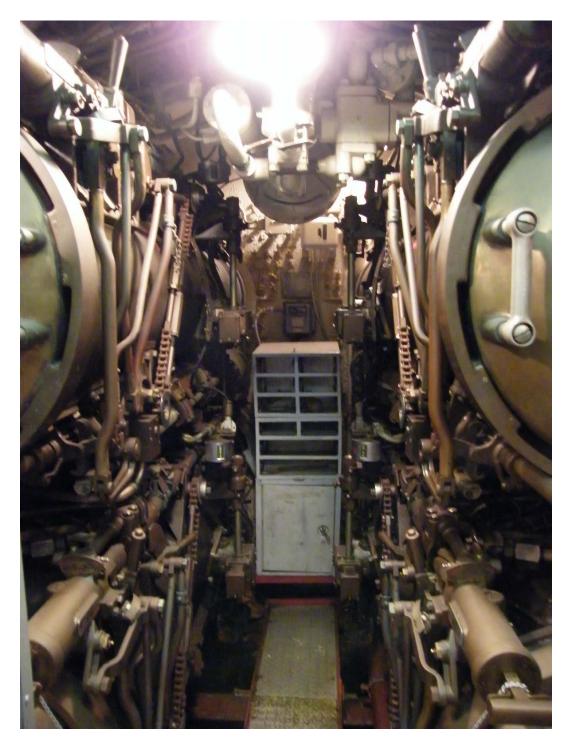
After bank of four torpedo tubes.

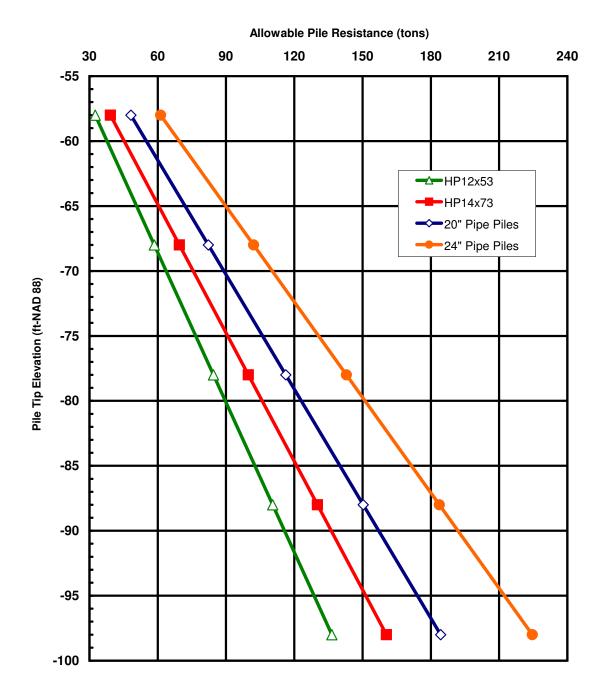
- 1) The structural capacity of the piles has not been considered in our analysis and should be evaluated by the project structural engineer.
- 2) The allowable tensile capacity is approximately $\frac{2}{3}$ of the compressive capacity.
- 3) The minimum recommended pile tip elevation is -58 ft-NAVD 88 (10 ft into the marl).
- 4) The recommended minimum center-to-center pile spacing is 3 pile diameters.

We recommend support of the rail system or crane trestle be achieved by installing driven piles. Figure A provides our recommended allowable axial capacities for steel HP12x53, HP14x73, 20-in. diameter pipe, and 24-in. diameter open-ended pipe piles.

An efficiency factor (to account for capacity reductions caused by group effects) of 1.0 should be used for center-to-center pile spacings of three pile diameters or more, which is the minimum recommended spacing. The structural capacity of the piles has not been considered in our analysis and should be checked by the Structural Engineer. The capacities shown in Figure A are based on the assumption that a pile load test program, as described below, will be implemented.

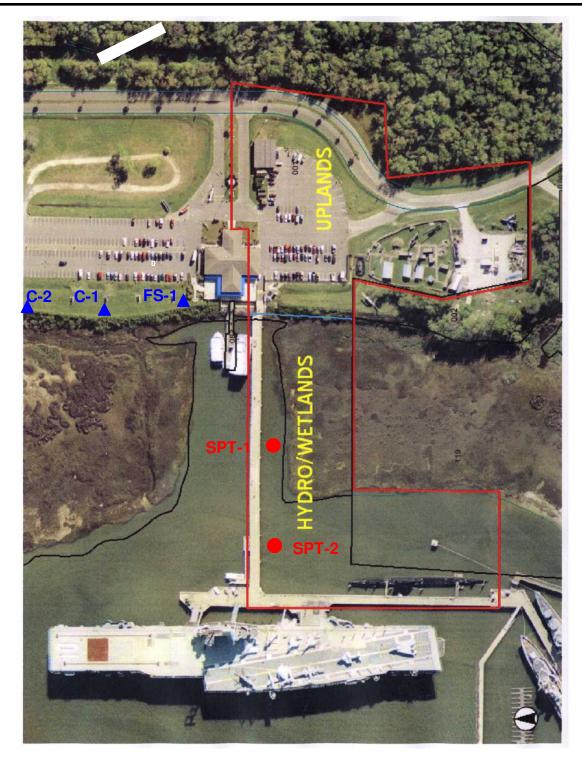
Figure 1

SPT Test Location Previous CPT Test Location

This site plan was adapted by S&ME.
Test locations are approximate.
Do not use for estimation of distances or quantities.

Test Location Plan (Figure 1)

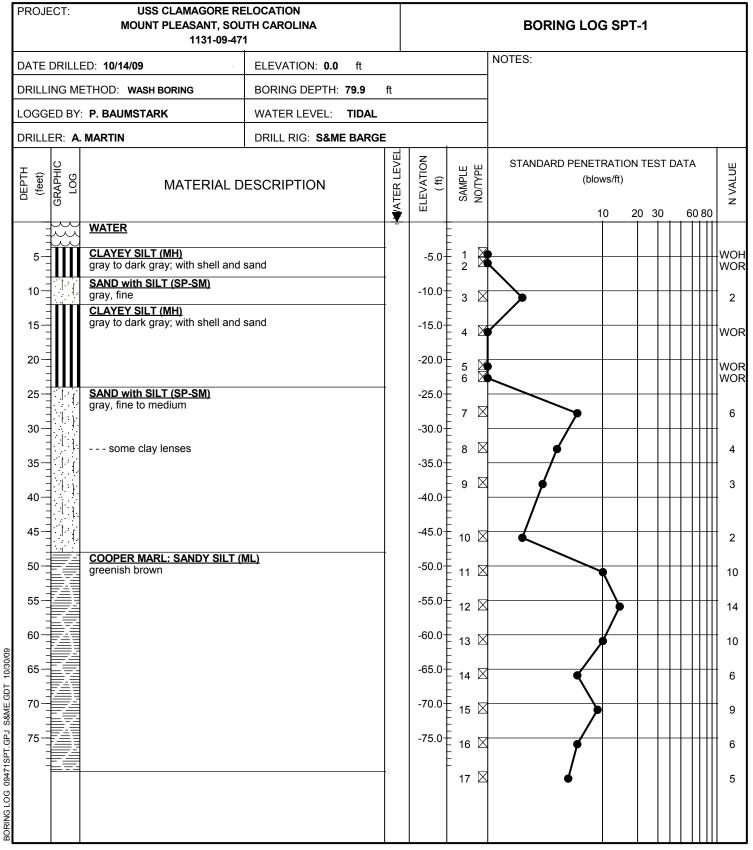
- 1. BORING AND SAMPLING IS IN ACCORDANCE WITH ASTM D-1586.
- 2. PENETRATION (N-VALUE) IS THE NUMBER OF BLOWS OF 140 LB. HAMMER FALLING 30 IN. REQUIRED TO DRIVE 1.4 IN. I.D. SAMPLER 1 FT.

The over water exploration initially encountered 20 to 30 ft of very soft clayey silt. Beneath the silty clay layer, the subsurface conditions generally consisted of very loose to loose sand to the top of the Cooper Marl³. The marl was encountered at a depth of about 40 ft below the mudline, which corresponds to an elevation of about -48 ft-NAVD88. The marl continued to the deepest explored depth of about 83 ft below the mudline. The water depth at the boring locations ranged from a low of 0 ft at SPT-1 to over 9 ft at SPT-2 during our investigation. Water levels at the site vary with tidal changes.

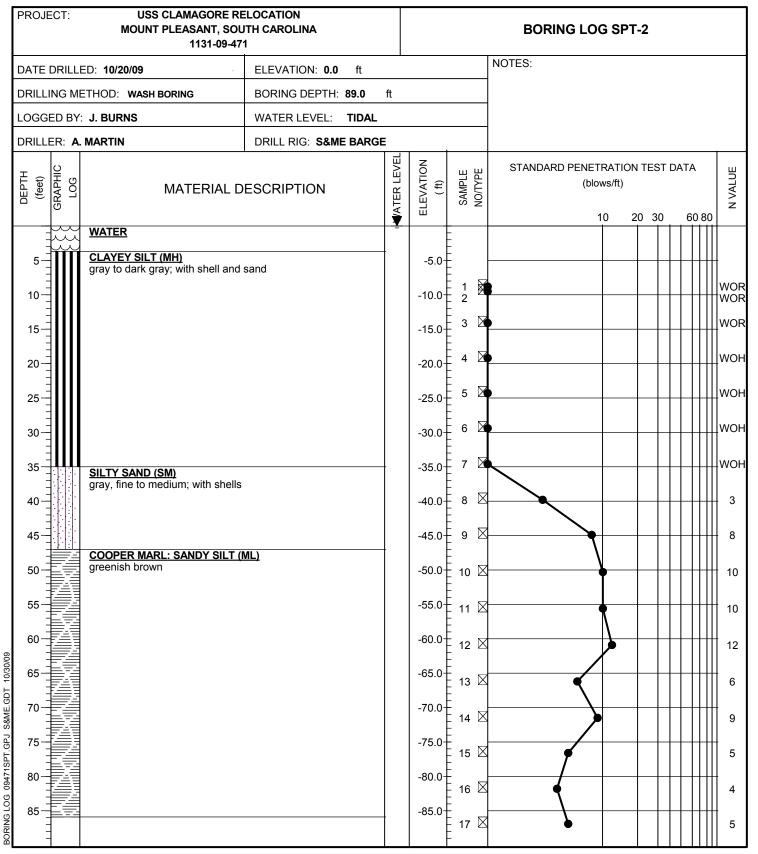
- 1. BORING AND SAMPLING IS IN ACCORDANCE WITH ASTM D-1586.
- 2. PENETRATION (N-VALUE) IS THE NUMBER OF BLOWS OF 140 LB. HAMMER FALLING 30 IN. REQUIRED TO DRIVE 1.4 IN. I.D. SAMPLER 1 FT.

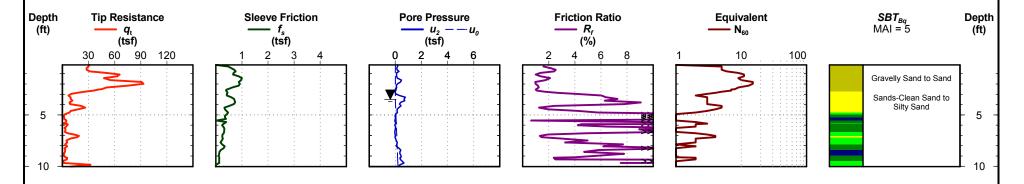
Rig/Operator: Gyrotrac/A. Feix

Total Depth: 10.0 ft
Termination Criteria: Target Depth

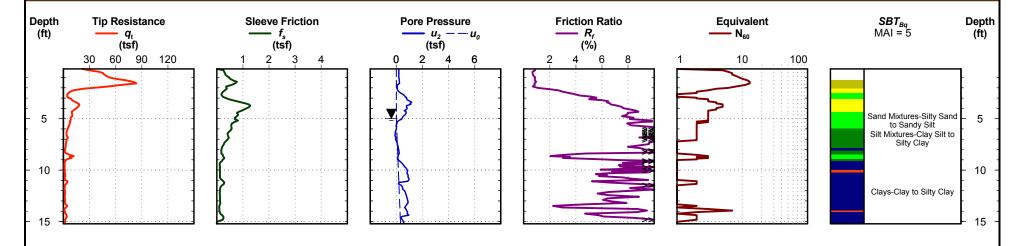
Cone Penetration Test C-14

Rig/Operator: Gyrotrac/A. Feix

Total Depth: 15.2 ft
Termination Criteria: Target Depth

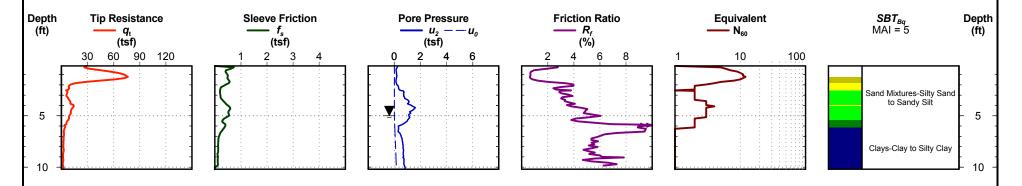
Cone Penetration Test C-15

Rig/Operator: Gyrotrac/A. Feix

Total Depth: 10.2 ft
Termination Criteria: Target Depth

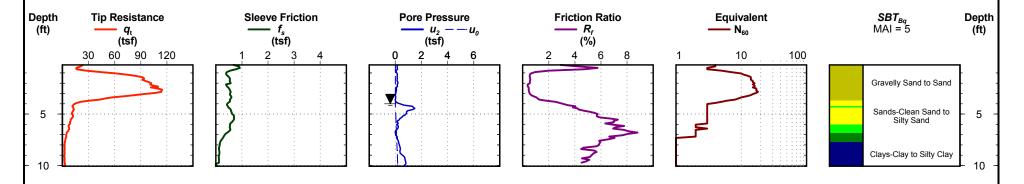
Cone Penetration Test C-16

Rig/Operator: Gyrotrac/A. Feix

Total Depth: 10.1 ft
Termination Criteria: Target Depth

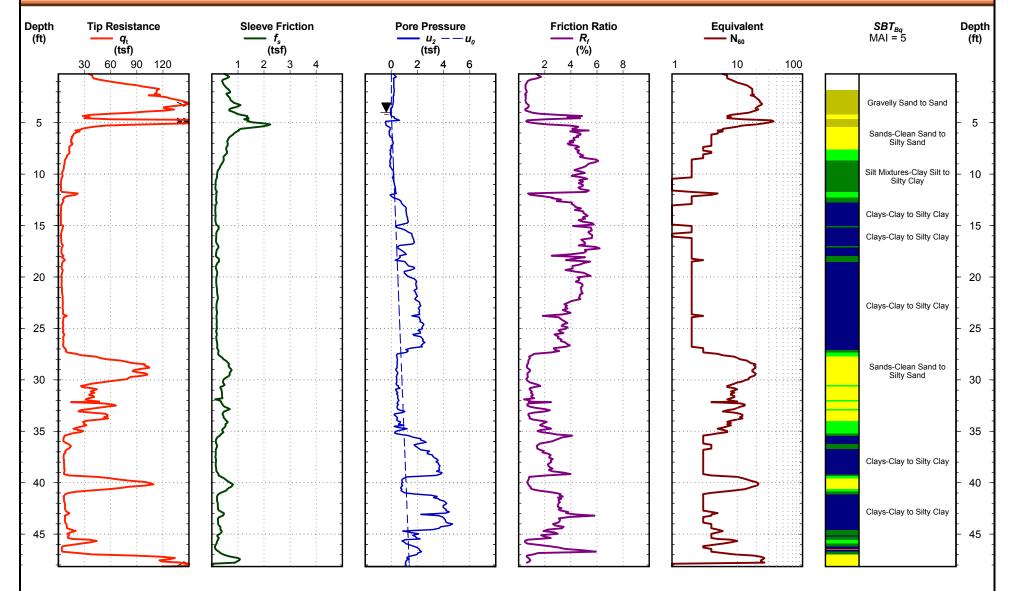
Cone Penetration Test C-17

Total Depth: 48.2 ft
Termination Criteria: Target Depth

Cone Size: 1.44

Electronic Filename: f21a0911c.ecp
